Dynamic Coast - National Coastal Change Assessment: Cells 8 and 9 - The Western Isles

Dynamic Coast – Scotland's National Coastal Change Assessment

Cells 8 and 9 - The Western Isles

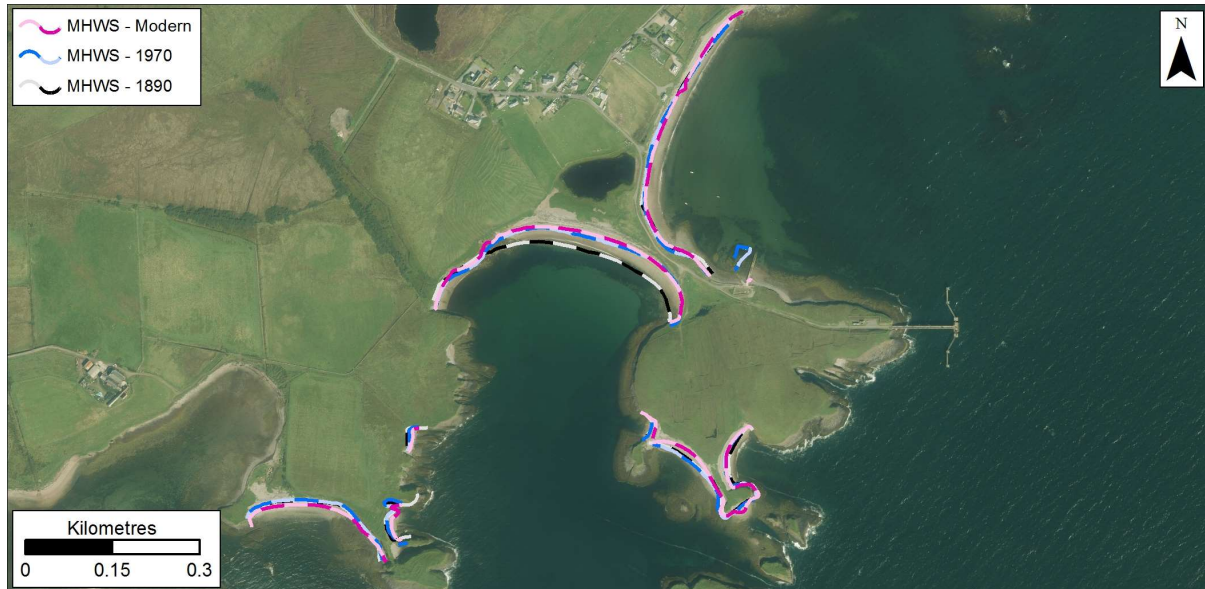
Historic Change: The small tombolo at Holm has undergone erosion on both sides between 1895 and 1964, with the maximum occurring on the south side of up to 30 m and then a further 10 m between 1964 and 2013 (Figure 8.3). The north coast lost up to 6m on average up to 1964 but has since been protected by boulder defences and a seaward movement of MHWS.

Figure 8.3: MHWS position in 1890, 1970s, and Modern datasets at Holm. Getmapping are our current providers of Scotland-wide digital aerial imagery© Getmapping plc.

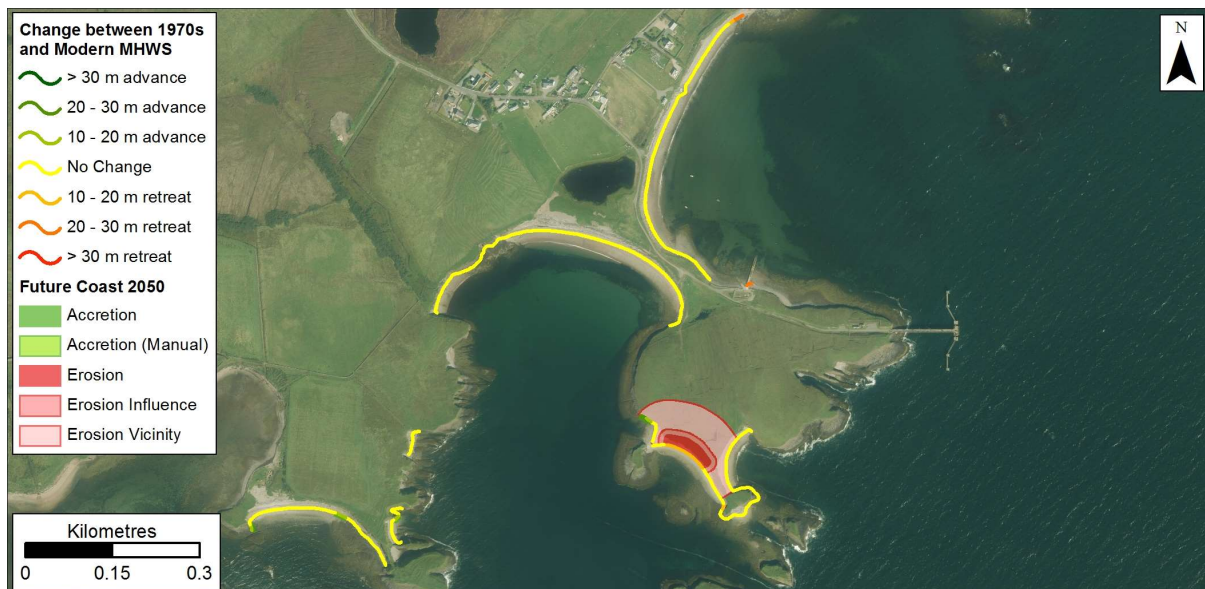
Figure 8.4: Possible future coastline position in 2050 based on rates between 1970 and Modern MHWS data at Holm. Getmapping are our current providers of Scotland-wide digital aerial imagery© Getmapping plc.

Future Vulnerability: Although recent erosion is limited on the south side of the tombolo, and is not flagged as an issue at present, the tombolo itself houses an oil pipeline and access road from a landing stage situated at the end of the islet to the east. As a result, it is an area that may be of concern in the

future if these rates change (Figure 8.4). The northern side is already protected and it may be that the south side requires similar protection in the future.

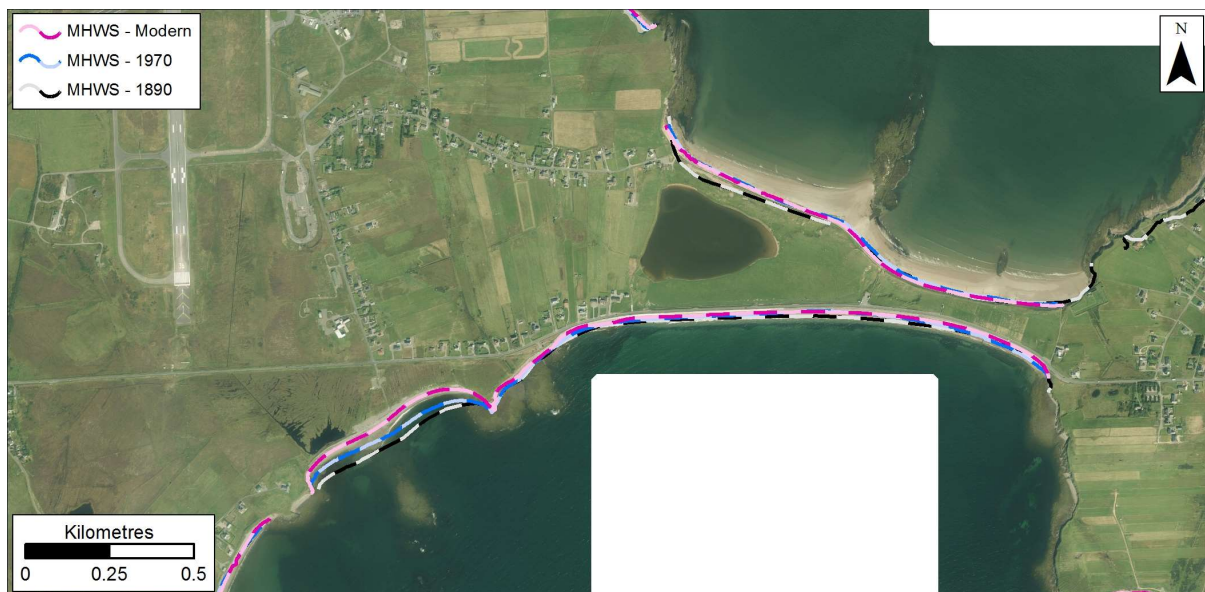
Historic Change: The Braigh tombolo connects mainland Lewis with the Point peninsula. Along the main tombolo the 1985 MHWS is closely matched by the 1964 and 2013 lines, except in the northwest where the modern line lies 40 m seaward of the 1895 line showing accretion along this section (Figure 8.5). The Braigh is defended by structures along both its south and north sides but in spite of this, there has been landward movement of the MHWS between 1964 and 2013. In the centre of the north side and in the southeast corner where there has been up to 20 m of erosion. This section of beach has groynes fitted and the losses relate to changes in beach position either side of the groynes and so may not be significant in the long term.

Of more concern is the area to the west of the south side of the Braigh. Here 30 m of beach was lost between 1895 and 1964 and a further 30 m to 2013 with modern aerial photography showing the vegetation edge of low lying marshy ground occurring some 20 m behind MHWS. Behind this runs the main road to Stornoway and the access road to Stornoway airport.

Figure 8.5: MHWS position in 1890, 1970s, and Modern datasets at the Braigh. Getmapping are our current providers of Scotland-wide digital aerial imagery © Getmapping plc.

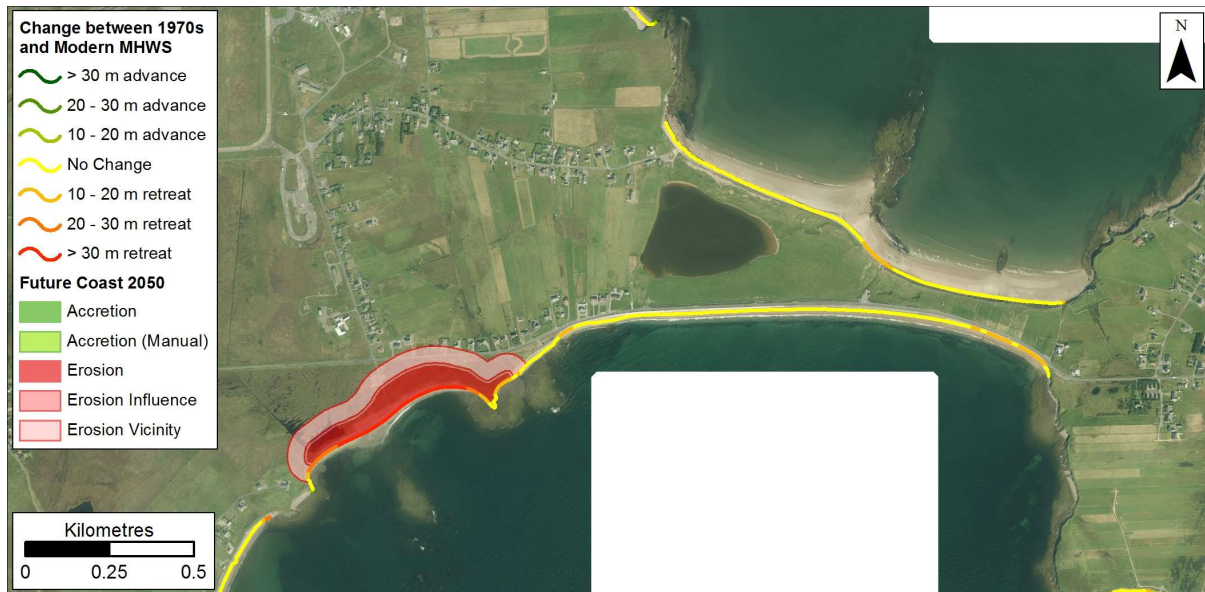
Figure 8.6: Possible future coastline position in 2050 based on rates between 1970 and Modern MHWS data at the Braigh. Getmapping are our current providers of Scotland-wide digital aerial imagery© Getmapping plc.

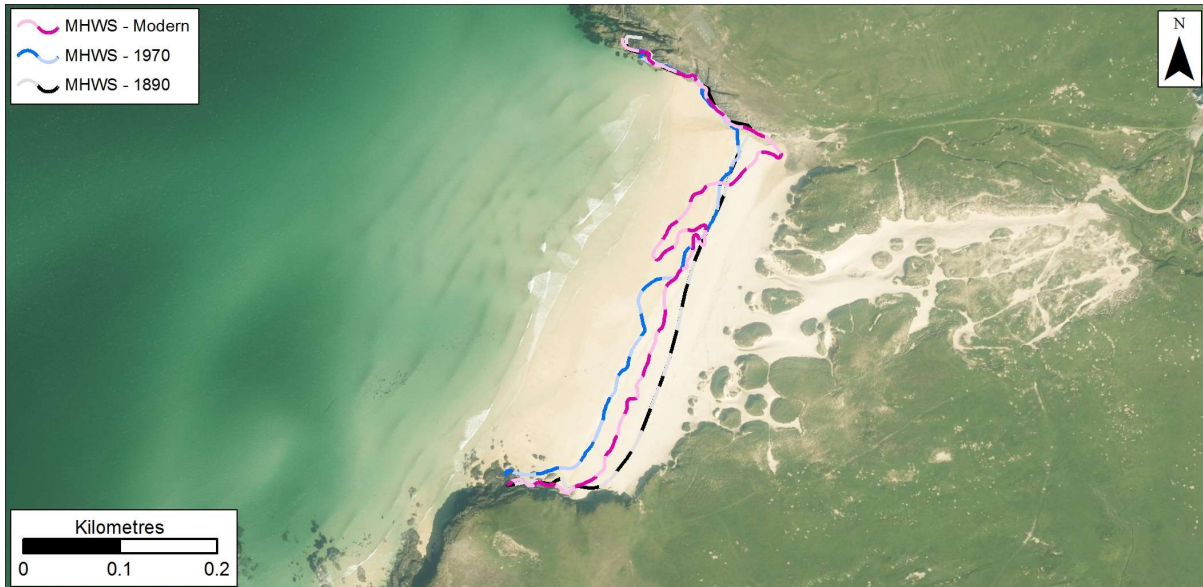
Figure 9.1: MHWS position in 1890, 1970s, and Modern datasets at Eorpie. Getmapping are our current providers of Scotland-wide digital aerial imagery© Getmapping plc.

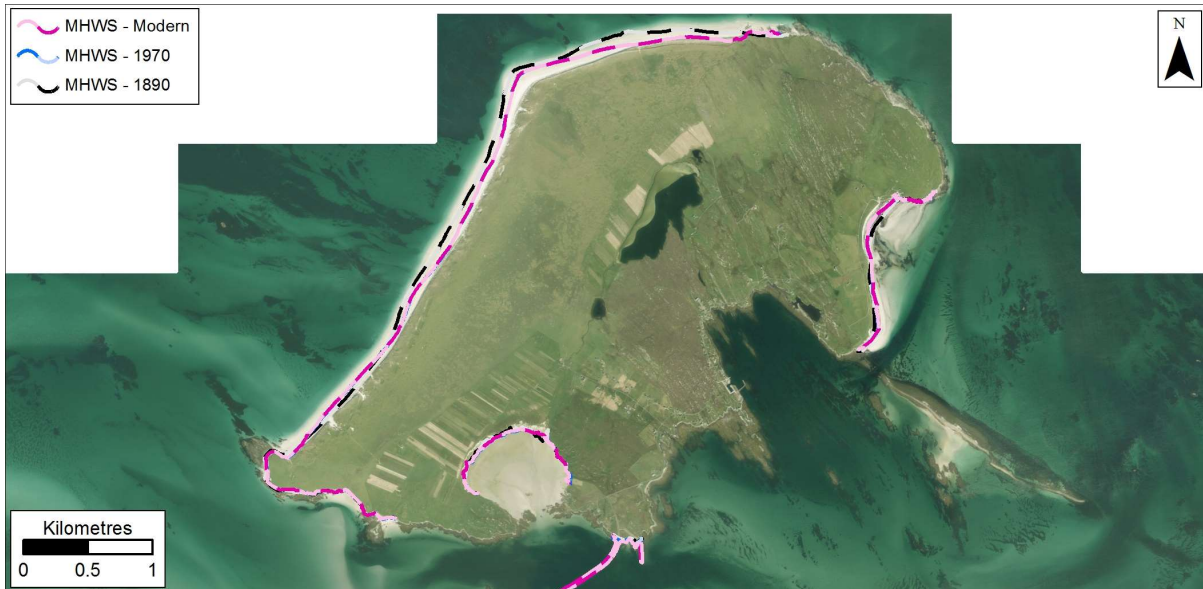
Figure 9.9: MHWS position in 1890, 1970s, and Modern datasets at Berneray. Getmapping are our current providers of Scotland-wide digital aerial imagery© Getmapping plc.

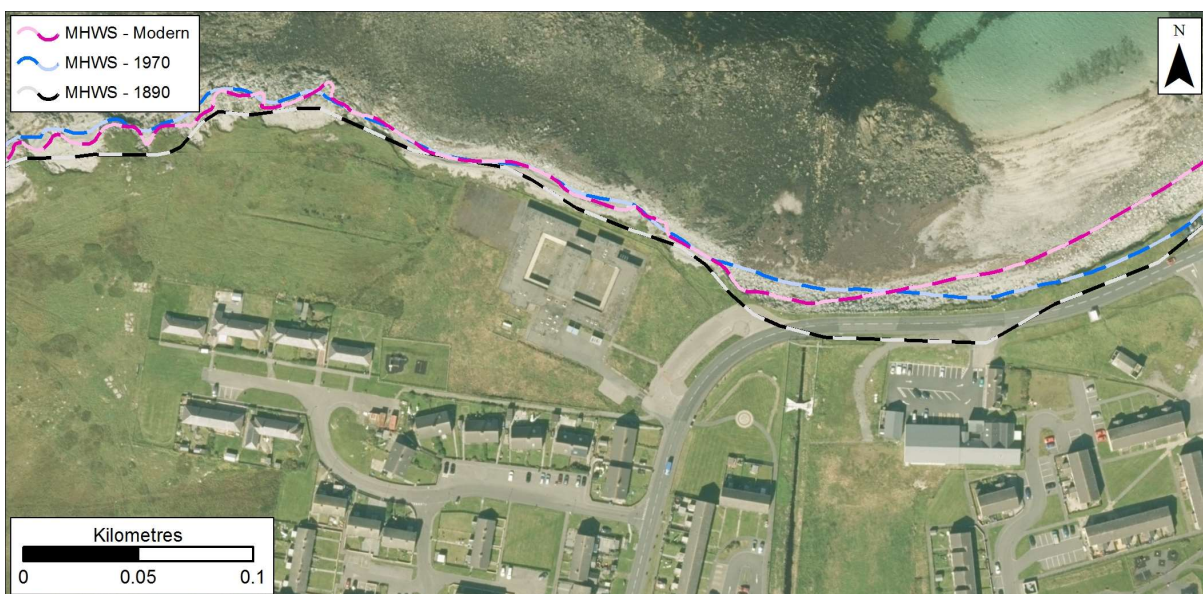
Figure 9.23: MHWS position in 1890, 1970s, and Modern datasets at Balivanich Primary School. Getmapping are our current providers of Scotland-wide digital aerial imagery© Getmapping plc.

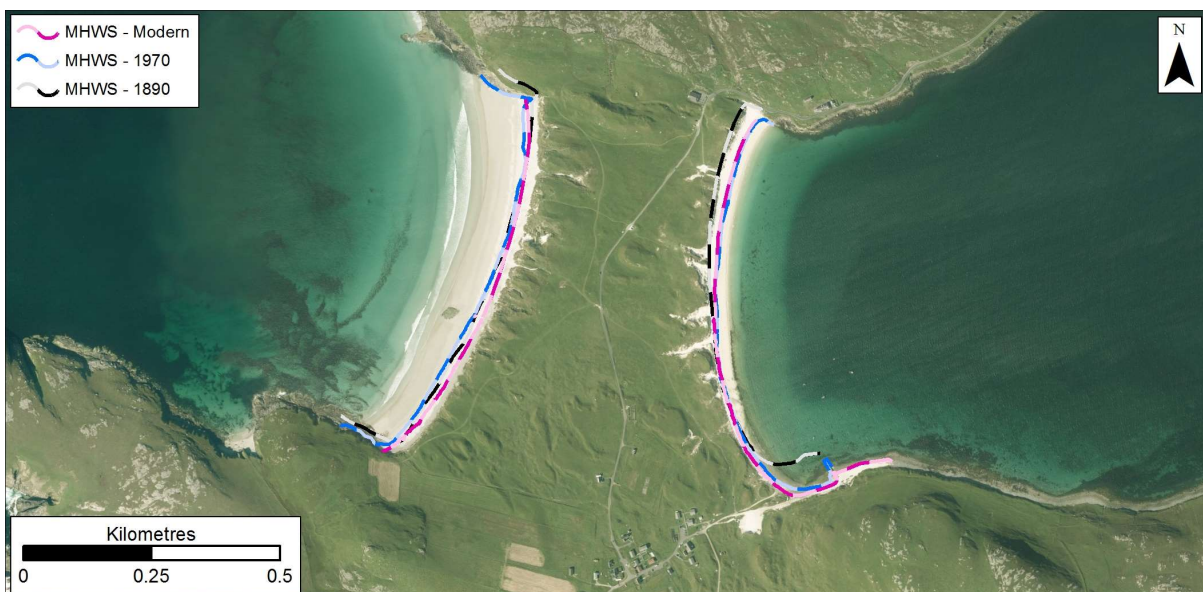
Figure 9.37: MHWS position in 1890, 1970s, and Modern datasets at Vatersay tombolo. Getmapping are our current providers of Scotland-wide digital aerial imagery © Getmapping plc.

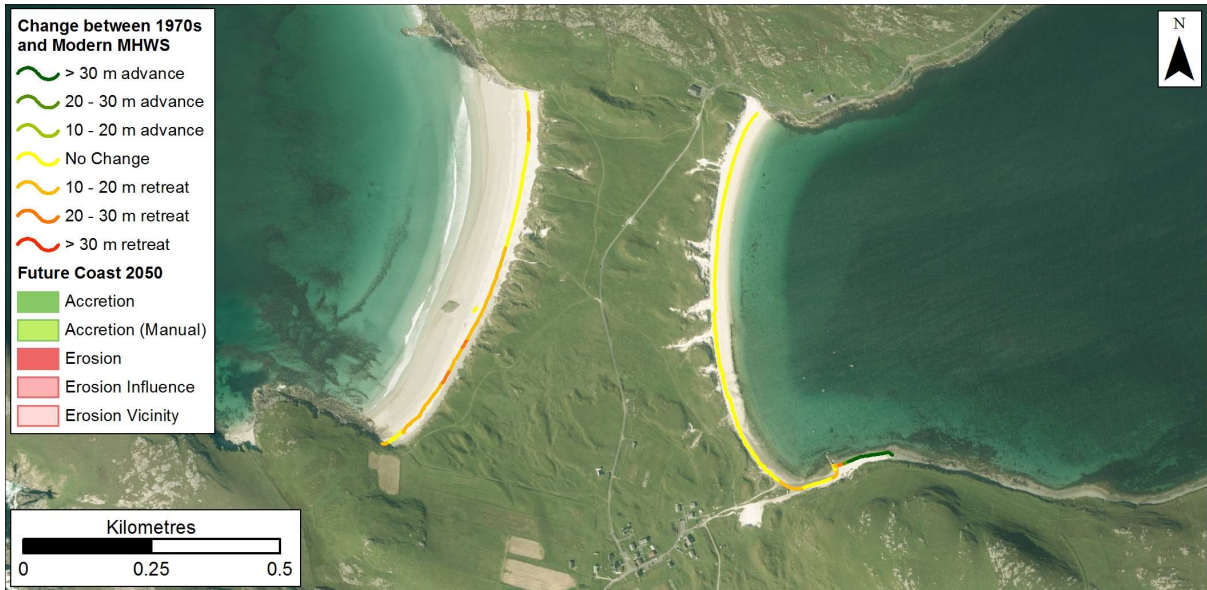
Figure 9.38: Change between the 1970 and Modern MHWS data at Veteransay tombolo. Getmapping are our current providers of Scotland-wide digital aerial imagery © Getmapping plc.

Future Vulnerability: No assets are close to the areas that might be affected by erosion in the future although wind-blown sand frequently veneers the roadway (Figure 9.38). It is also likely that any erosion of the east face can be addressed with soft coastal management techniques such as dune rehabilitation. Although, erosion is noted on the western bay, this is not expected to continue in the future due to the resilience of the hinterland as estimated by the Underlying Physical Susceptibility Model (Fitton et al., (2016)).
