Dynamic Coast - National Coastal
Change Assessment:

Please reference this report as follows: Rennie, A.F., Hansom, J.D., and Fitton, J.M. (2017) Dynamic Coast - National Coastal Change Assessment: Cell 10 - Orkney, CRW2014/2

Dynamic Coast - Scotland's National Coastal Change Assessment

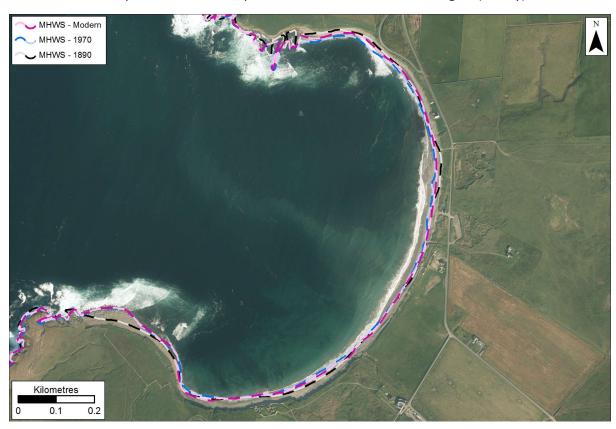
Figure 10.3: MHWS position in 1890, 1970s, and Modern datasets at Bay of Skaill. Getmapping are our current providers of Scotland-wide digital aerial imagery® Getmapping plc.

Between 1900 and 1972 the position of MHWS has remained largely stable with some isolated areas of accretion over the 72 years (Figure 10.3). At first glance this contrasts with the evidence of long-lived storm driven coastal erosion. However, this is inconsistent in that short-term changes can mask longer term trends. In addition, it is also possible for the upper beach to respond differently to waves than lower sections of the beach so that the upper beach (above MHWS) may experience

Whilst the 1972 MHWS is largely coincident within the vicinity of the sea wall at Skara Brae, accretion has occurred between the end of the defences and the Mill at Voydale to the east, with the tide line moving some 14 m seaward (0.2 m/yr) (Figure 10.4). The Mill House appears at the edge of the beach in 1972, with all four walls intact. Since all that now remains is the landward wall before the seaward edge of the dune is encountered, this indicates upper beach and dune retreat despite apparent MHWS stability. Additionally, the changing position of the dune vegetation edge within air photography commissioned by Historic Scotland in 2003, showed 0.3-0.4 m/yr erosion. Further north east of the Mill the 1972 and 1900 tidelines are largely coincident for the next 400 m, northward of which MHWS has advanced seawards between 1900 and 1972 by up to 20 m (0.3 m/yr). Within the remainder of the bay (to the north) MHWS has advanced seawards between 1900 and 1972, by up to 20m (0.3 m/yr) (Figure 10.3).

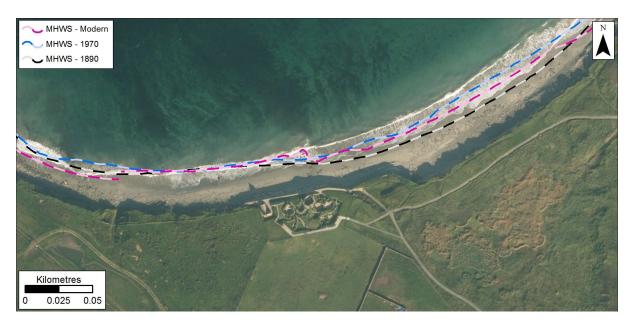
Figure 10.4: MHWS position in 1890, 1970s, and Modern datasets at Skara Brae. Getmapping are our current providers of Scotland-wide digital aerial imagery© Getmapping plc.

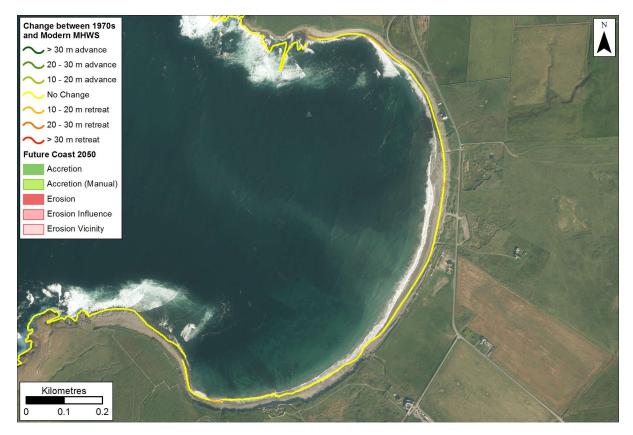
Figure 10.6: Possible future coastline position in 2050 based on rates between 1970 and Modern MHWS data at Bay of Skaill. Getmapping are our current providers of Scotland-wide digital aerial imagery © Getmapping plc.

Future Vulnerability: Whilst the Neolithic village at Skara Brae lies behind a sea wall, the remainder of the bay is largely undefended apart from unofficial tyre and netting defences fronting a house further north (Sea View). The Mill House at Voydale has been largely lost since 1972. The changes at the Bay of Skaill may highlight a possible disconnect between MHWS and the beach crest / vegetation edge, as such further analysis is required before a detailed vulnerability assessment can be carried out. Rates of recent MHWS retreat shown by the TLS in the rest of the bay are modest (15m in 44 years = 0.3 m/yr) (Figure 10.6), however it is not clear if this sample of the bay is representative of a wider pattern.

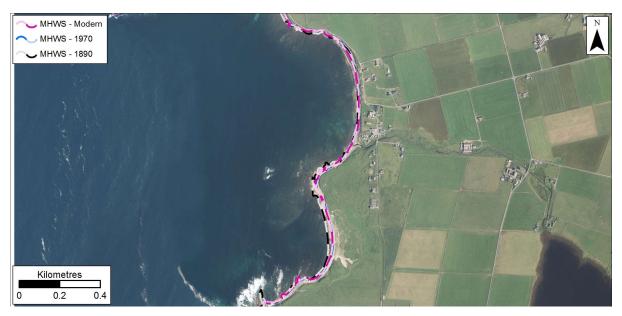
Figure 10.7: MHWS position in 1890, 1970s, and Modern datasets at Birsay Bay. Getmapping are our current providers of Scotland-wide digital aerial imagery© Getmapping plc.

At Brough Head modest changes occur to the alignment of the gravel beach at the end of the tidal causeway. More significant changes occur at the eastern end of the causeway on both Mainland Shores of the Point of Buckquoy. On the north shore, the 1974 MHWS line lies some 30 to 40 m inland of the 1900 equivalent and suggests that the soft erodible glacial tills that lie on top of the bedrock shore platform have been removed over this period. Indeed, the current position of the cliff line and vegetation limit lies up to 20 m landward of the 1971 MHWS position along much of this stretch of exposed coast.

Further south within Birsay Bay there has been very modest and statistically insignificant erosion within the vicinity of the Earl's Palace (up to 7m between 1903 and 1971, 0.1m/yr). However, given the density of cultural heritage within the bay this may present a significant risk. Some 60 m of defences were installed in front of the historically important graveyard that reclaimed 2-3 m of land from the beach, although the 1903 map shows the buildings were then just as perilously close to the beach as they are currently.

Further south from the Earl's Palace, towards Point of Snusan and Mount Misery, erosion increases with up to 20 m losses occurring between 1900 and 1974 (0.3m/yr). This is compounded by a further 10 m of loss beyond the 1971 line to where the vegetation and cliff line is depicted in the modern air photography. Like many of the exposed beaches here, extensive storm deposits lie above MHWS.

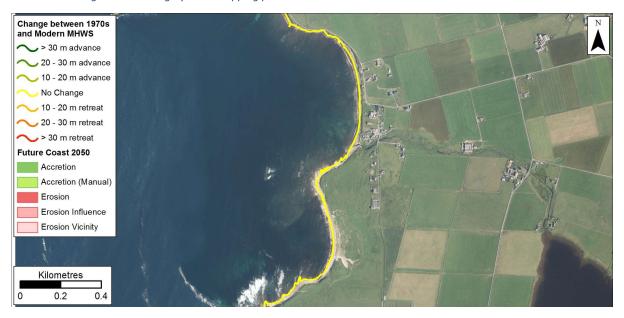
Figure 10.8: Possible future coastline position in 2050 based on rates between 1970 and Modern MHWS data at Birsay Bay. Getmapping are our current providers of Scotland-wide digital aerial imagery© Getmapping plc.

Future Vulnerability: As the the latest MHWS line is the same as the 1971 MHWS position, 'no change' is seen to have occurred at this location (Figure 10.8). Possible future change is therefore not estimated here. Apart from the farm buildings and church at Birsay, much of the land lies in agricultural use. However, from an archaeological perspective vulnerability might be gauged to be higher since there are known archaeological and cultural heritage interests within this area and there is potential for unknown sites that remain to be found.

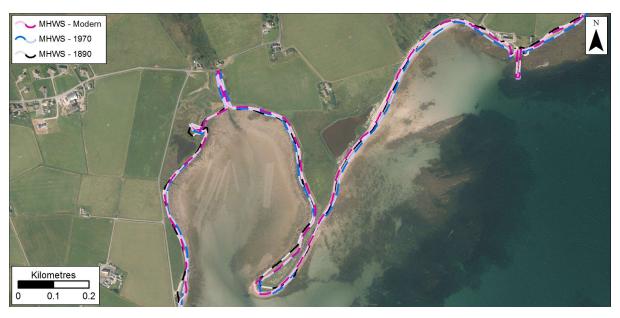
Figure 10.9: MHWS position in 1890, 1970s, and Modern datasets at Tankerness. Getmapping are our current providers of Scotland-wide digital aerial imagery© Getmapping plc.

Historic Change: Between 1900 and 1969, the southward extending 1km long spit at Tankerness has undergone accretion along much its east face, but erosion of up to 13 m on its west face (Figure 10.9). Between 1969 and 2014, this has been reversed to show up to 12 m of erosion on the north, east, and west faces.

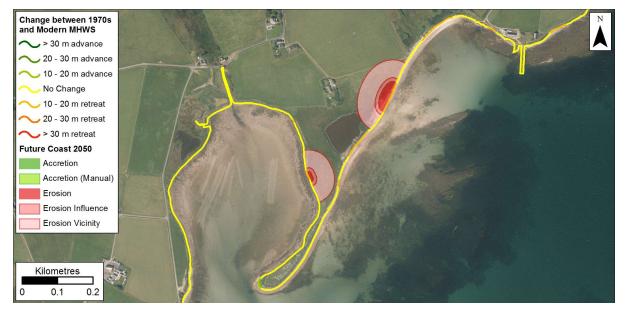
Figure 10.10: Possible future coastline position in 2050 based on rates between 1970 and Modern MHWS data at Tankerness. Getmapping are our current providers of Scotland-wide digital aerial imagery© Getmapping plc.

Future Vulnerability: Since there are no assets within the vicinity, any vulnerability relates to undeveloped and semi-natural shore. The lagoon that is enclosed by the east facing shore may become breached to threaten the integrity of the spit point to the south (Figure 10.10).

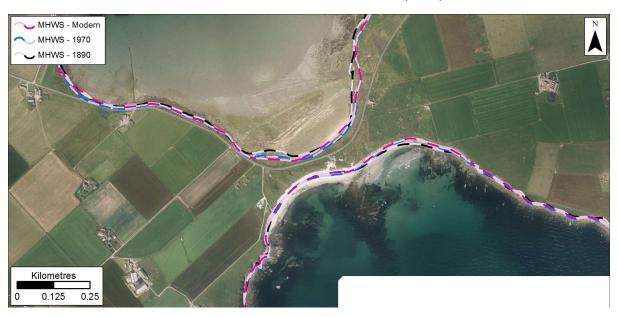
Figure 10.11: MHWS position in 1890, 1970s, and Modern datasets at Dingieshowe Bay. Getmapping are our current providers of Scotland-wide digital aerial imagery© Getmapping plc.

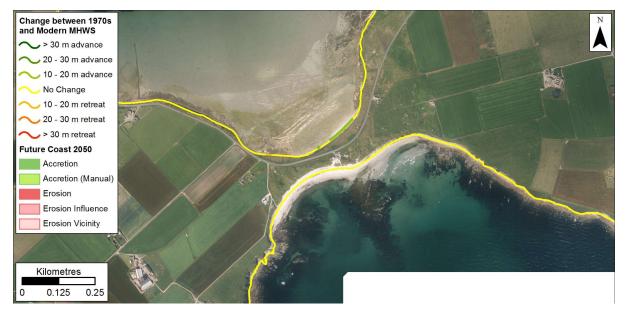
Figure 10.12: Possible future coastline position in 2050 based on rates between 1970 and Modern MHWS data at Dingieshowe Bay. Getmapping are our current providers of Scotland-wide digital aerial imagery© Getmapping plc.

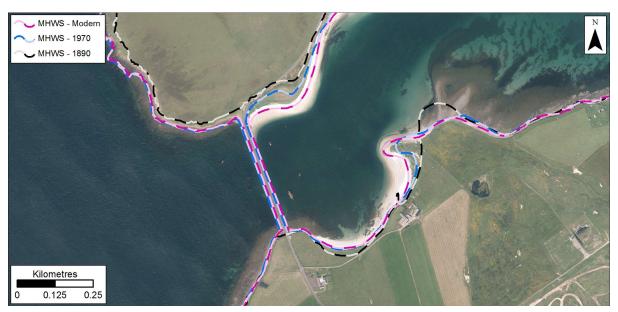
Figure 10.13: MHWS position in 1890, 1970s, and Modern datasets at Churchill Barrier No. 3. Getmapping are our current providers of Scotland-wide digital aerial imagery© Getmapping plc.

Historic Change: The Churchill Barriers were formed in the Second World War from cement blocks to connect Mainland Orkney to the islands of Lamb Holm, Glimps Holm, Burray and South Ronaldsay and so close off the pre-existing narrows. Small changes can be found on the shores adjacent to the first three northern barriers. Here, the blocking of the narrows has resulted in the advance of MHWS by up to 80 m metres (1m/yr) or the retreat of MHWS of up to 60m metres (0.7m/yr) as shown at Churchill Barrier No. 3 at Weddell Sound (Figure 10.13). However, the most impressive changes have occurred along the eastern flank of the fourth barrier that connects South Ronaldsay with Burray (Figure 10.14). The construction of the barrier interrupted the westward sediment supply from the North Sea into Scapa Flow. Between 1903 and 1983 up to 120 m accreted on the southern shore at Ayres of Cara (1.5 m/yr) and 70m on the northern shore (0.8 m/yr) However, the barriers were constructed between 1940 and 1944, meaning the rates are double that stated. Block ships that were scuttled in deep water before WW2 have been submerged by accreting sand for decades and are now found buried within the interior of the dunes. Such was the rate of accretion of sand that Orkney Council used the interior of the dunes as a sand quarry for many years.

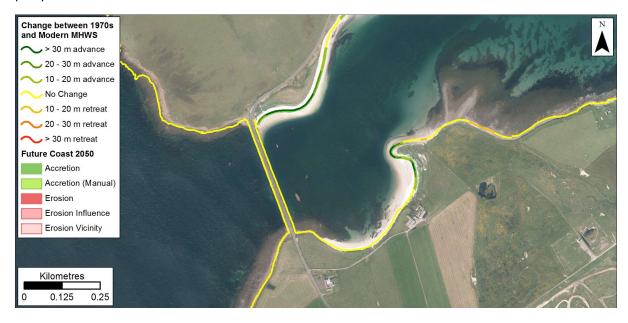
Figure 10.15: Possible future coastline position in 2050 based on rates between 1970 and Modern MHWS data at Churchill Barrier No. 3. Getmapping are our current providers of Scotland-wide digital aerial imagery© Getmapping plc.

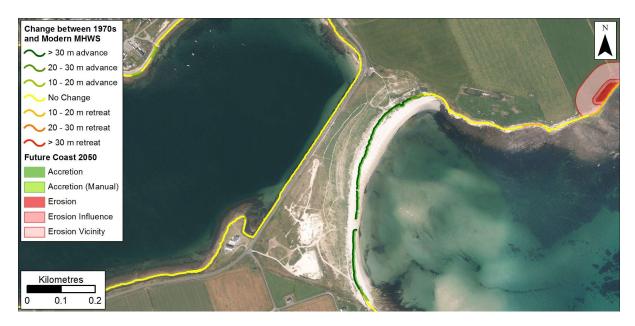
Figure 10.16: Possible future coastline position in 2050 based on rates between 1970 and Modern MHWS data Churchill Barrier No. 4. Getmapping are our current providers of Scotland-wide digital aerial imagery© Getmapping plc.

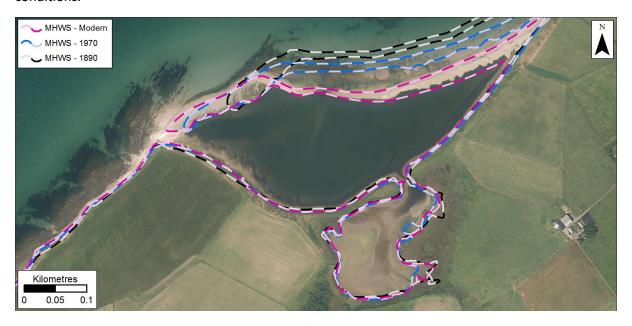
Figure 10.17: MHWS position in 1890, 1970s, and Modern datasets at Long Ayre. Getmapping are our current providers of Scotland-wide digital aerial imagery© Getmapping plc.

Historic Change: Long Ayre is a 700 m gravel spit that extended west by 80 m between 1900 and 1964 (1.3 m/yr), enclosing a lagoon (Figure 10.17). Up to 37 m of erosion (0.5 m/yr) at the eastern (proximal) end of the spit fuels accretion of the westward (distal) end. Since 1964, modest changes have occurred (less than 10 m on the open coast:) but the southward movement continues at its eastern end with the distal end extending west by 15 m over 46 years (0.3 m/yr). The lagoon is not yet fully enclosed and there is tidal exchange at its western end as well as overwash during stormy conditions.

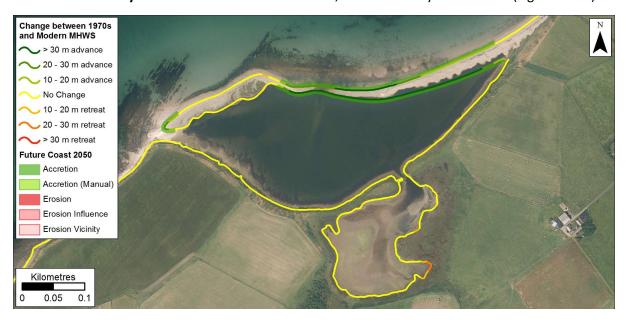
Figure 10.18: Possible future coastline position in 2050 based on rates between 1970 and Modern MHWS data at Long Ayre. Getmapping are our current providers of Scotland-wide digital aerial imagery© Getmapping plc.

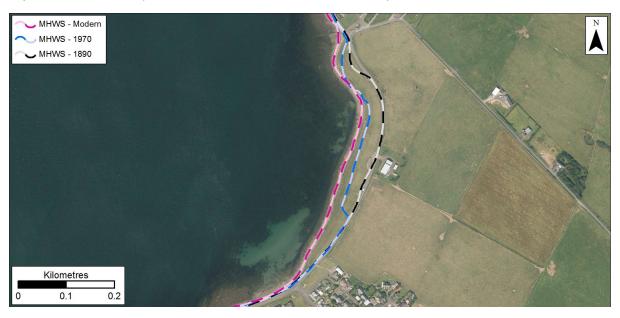
Figure 10.21: MHWS position in 1890, 1970s, and Modern datasets at the Bay of Weyland. Getmapping are our current providers of Scotland-wide digital aerial imagery© Getmapping plc.

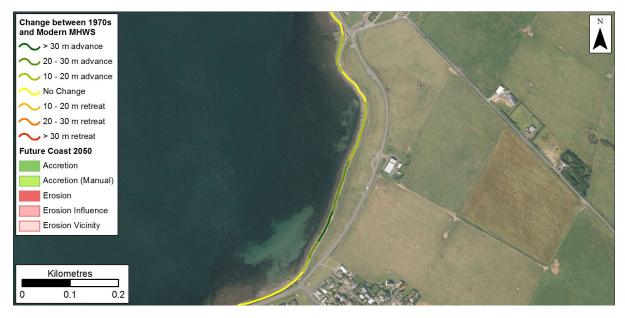
Figure 10.22: Possible future coastline position in 2050 based on rates between 1970 and Modern MHWS data at the Bay of Weyland. Getmapping are our current providers of Scotland-wide digital aerial imagery© Getmapping plc.

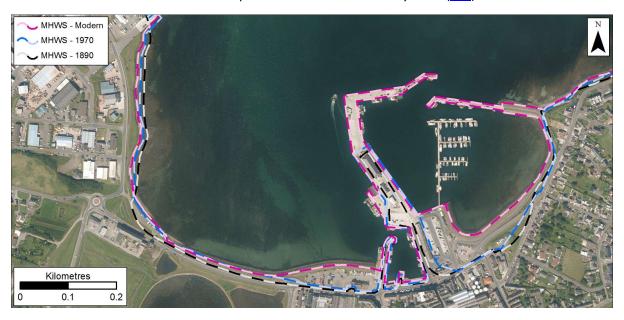
Figure 10.23: MHWS position in 1890, 1970s, and Modern datasets at Kirkwall. Getmapping are our current providers of Scotland-wide digital aerial imagery© Getmapping plc.

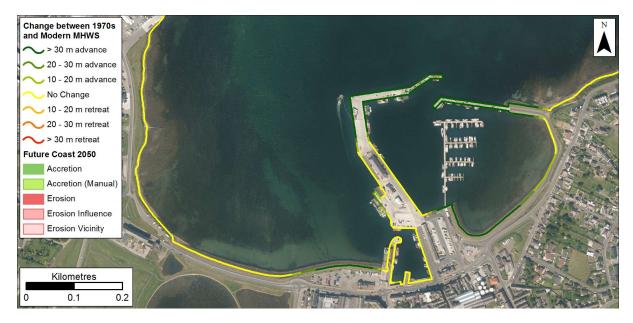
Figure 10.24: Possible future coastline position in 2050 based on rates between 1970 and Modern MHWS data at Kirlkwall. Getmapping are our current providers of Scotland-wide digital aerial imagery© Getmapping plc.

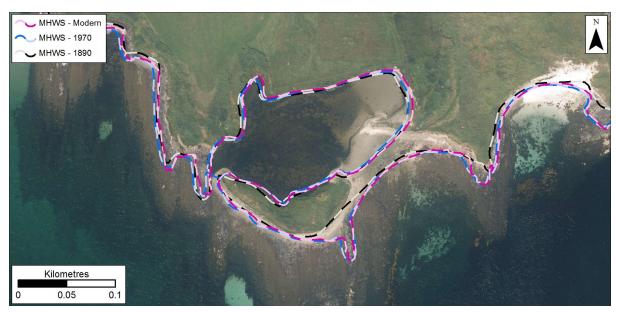
Figure 10.25: MHWS position in 1890, 1970s, and Modern datasets at Mae Sand. Getmapping are our current providers of Scotland-wide digital aerial imagery© Getmapping plc.

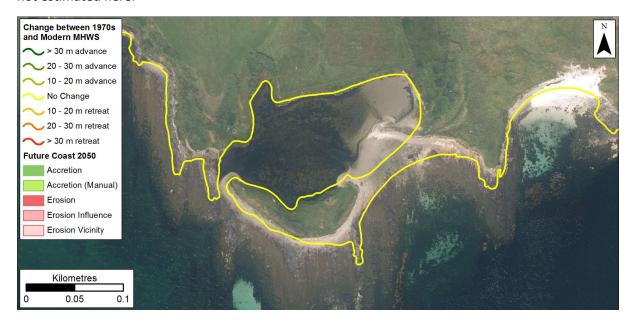
Figure 10.26: Possible future coastline position in 2050 based on rates between 1970 and Modern MHWS data at Mae Sand. Getmapping are our current providers of Scotland-wide digital aerial imagery© Getmapping plc.

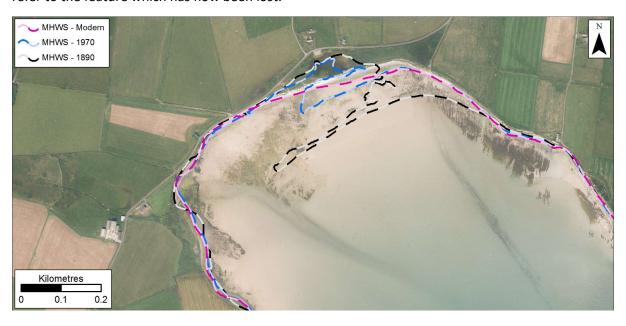
Figure 10.27: MHWS position in 1890, 1970s, and Modern datasets at the Bay of Tuquoy. Getmapping are our current providers of Scotland-wide digital aerial imagery© Getmapping plc.

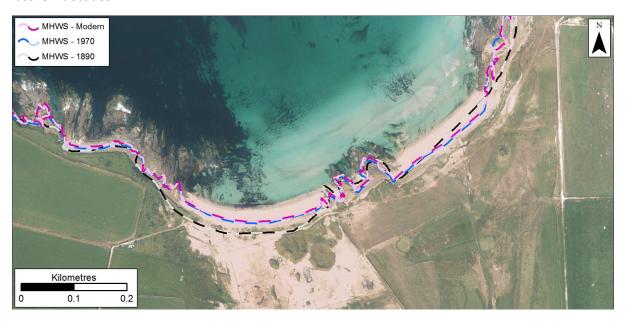
Figure 10.29: MHWS position in 1890, 1970s, and Modern datasets at the Links of Notland. Getmapping are our current providers of Scotland-wide digital aerial imagery© Getmapping plc.

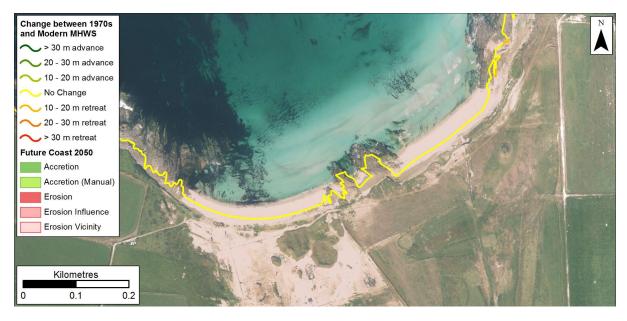
Figure 10.30: Possible future coastline position in 2050 based on rates between 1970 and Modern MHWS data at the Links of Notland. Getmapping are our current providers of Scotland-wide digital aerial imagery© Getmapping plc.

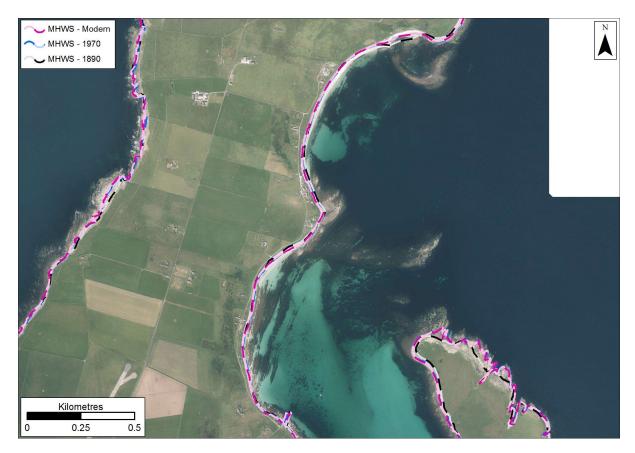
Figure 10.31: MHWS position in 1890, 1970s, and Modern dataset son Papa Westray. Getmapping are our current providers of Scotland-wide digital aerial imagery © Getmapping plc.

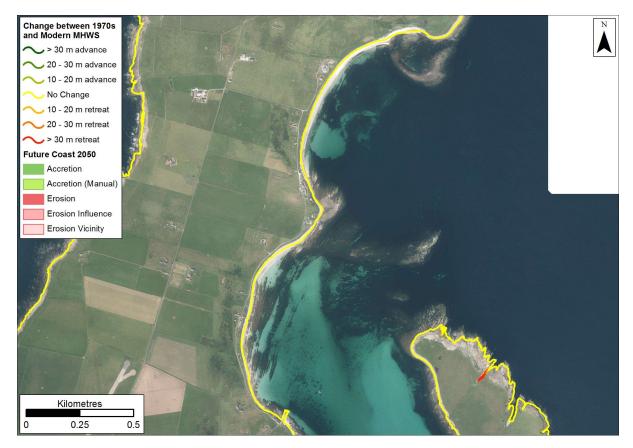
Figure 10.32: Possible future coastline position in 2050 based on rates between 1970 and Modern MHWS data on Papa Westray. Getmapping are our current providers of Scotland-wide digital aerial imagery© Getmapping plc.

Future Vulnerability: As the the latest MHWS line is the same as the 1975 MHWS position, 'no change' is recorded at this location (Figure 10.32). Nevertheless, the modern aerial photography shows that recession continues and the viability of the road that parallels the coast and provides access to the coastal properties that lie on both sides of the road is vulnerable in places and is a cause for concern in the future.

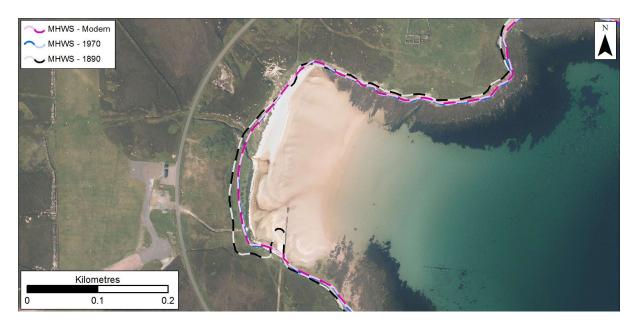
Figure 10.33: MHWS position in 1890, 1970s, and Modern datasets at the Bay of London. Getmapping are our current providers of Scotland-wide digital aerial imagery© Getmapping plc.

Historic Change: At the Bay of London (Figure 10.33) on the east side of Eday there has been up to 10m accretion since 1900 and 1971. Prior to that the roadway crossed the bay on a causeway that has been eroded before 1900 but whose traces remain. Over the modern period some 8m of accretion has occurred in the bay centre, according to the OS MHWS. However in reality, 28m of accretion is shown by the photography although this does taper away to zero at the north and south ends.

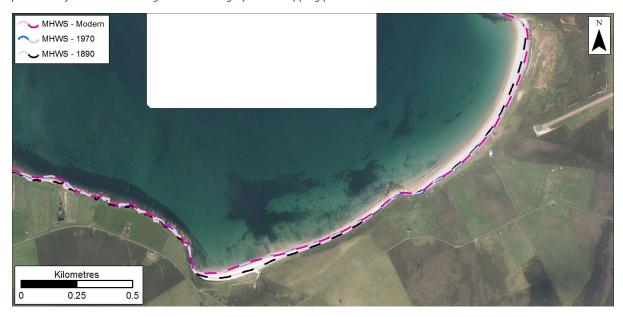
Figure 10.34: MHWS position in 1890, 1970s, and Modern datasets at the Sand of Doomy/Sands of Mussetter. Getmapping are our current providers of Scotland-wide digital aerial imagery© Getmapping plc.

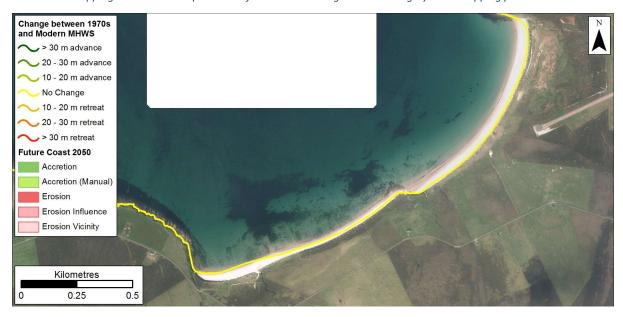
Figure 10.36: Possible future coastline position in 2050 based on rates between 1970 and Modern MHWS data at the Sand of Doomy/Sands of Mussetter. Getmapping are our current providers of Scotland-wide digital aerial imagery© Getmapping plc.

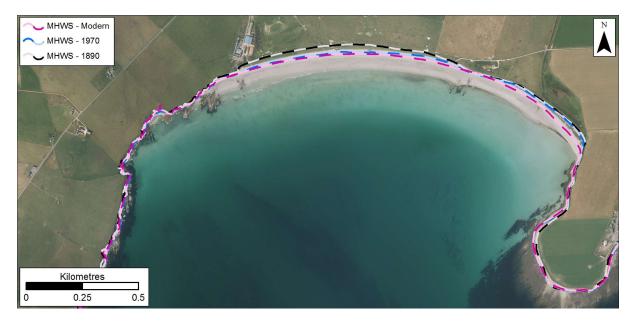
Figure 10.37: MHWS position in 1890, 1970s, and Modern datasets at Backaskail Bay. Getmapping are our current providers of Scotland-wide digital aerial imagery© Getmapping plc.

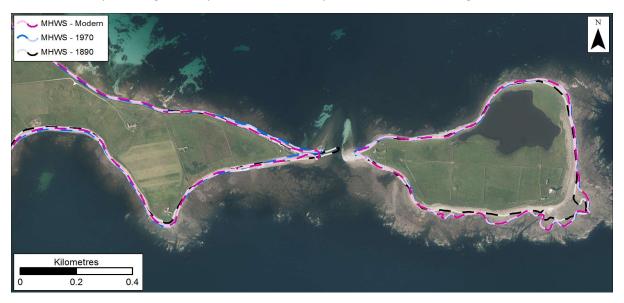
Figure 10.39: MHWS position in 1890, 1970s, and Modern datasets at Start Point. Getmapping are our current providers of Scotland-wide digital aerial imagery© Getmapping plc.

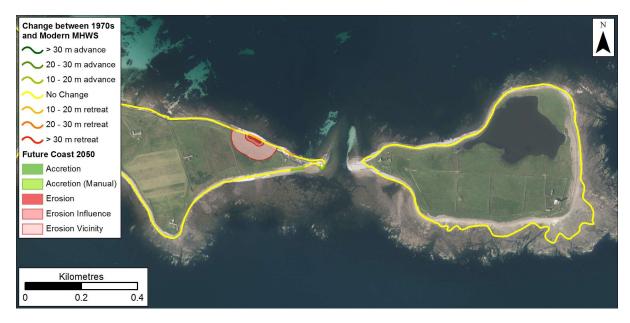
Figure 10.40: Possible future coastline position in 2050 based on rates between 1970 and Modern MHWS data at Start Point. Getmapping are our current providers of Scotland-wide digital aerial imagery. Getmapping plc.

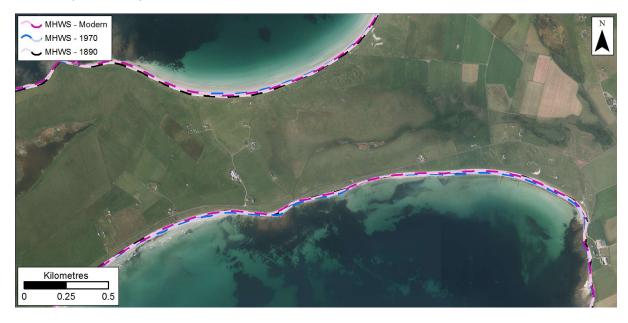
Figure 10.41: MHWS position in 1890, 1970s, and Modern datasets at the Bay of Sandquoy and Lopness. Getmapping are our current providers of Scotland-wide digital aerial imagery© Getmapping plc.

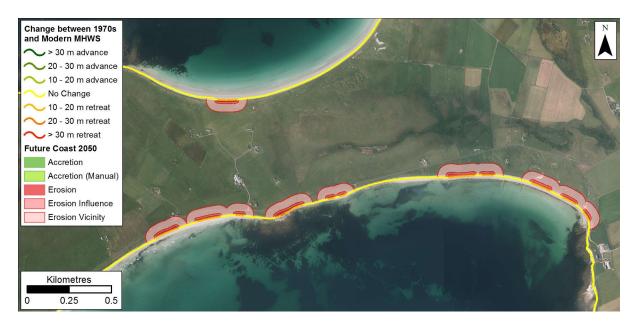
Figure 10.42: Possible future coastline position in 2050 based on rates between 1970 and Modern MHWS data at the Bay of Sandquoy and Lopness. Getmapping are our current providers of Scotland-wide digital aerial imagery© Getmapping plc.

Future Vulnerability: Both beaches are backed by low dunes that give way to a negative gradient inland to very low-lying ground. In Sandquoy, a 130 m length in the centre of the bay is anticipated to erode by another 13 m by 2050, and in the south at Lopness, nine areas covering 2.2 km of the east of the 4.5 km long bay give cause for concern (Figure 10.42). The anticipated erosion affects 150 m of the B9069 at the Loch of Langamay burn exit, and a further 1.2 km lies within the area of erosion vicinity. Given that the dune gradients fall landward then the erosion vicinity overlap onto the road is a real cause for concern. There is further cause for concern if erosion progresses into the future and removes either, or both, of the dune ridges that back both bays and allowing marine incursion into the areas to the rear. This will raise the possibility of the area of Northwall and Tofts Ness becoming separated from mainland Sanday. The B9069 roadway closely parallels the arc of Lopness Bay and in places lies within 2 m of MHWS at the exit of the Loch of Langamay burn, where a short seawall occurs. By 2050 this length of road and the low-lying area behind is anticipated to be vulnerable to erosion and flooding.

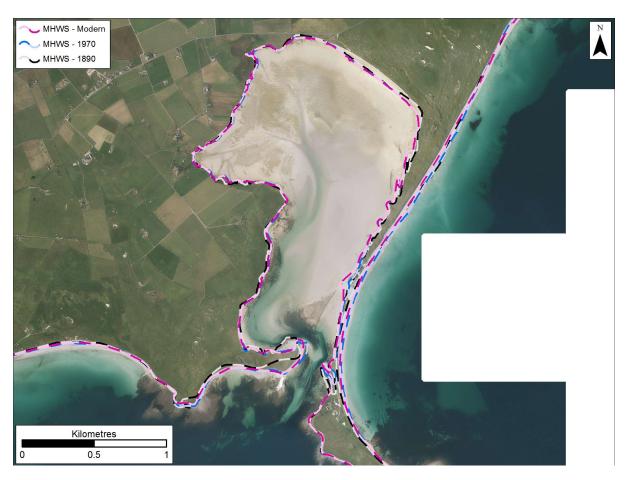
Figure 10.43: MHWS position in 1890, 1970s, and Modern datasets at Cata Sands. Getmapping are our current providers of Scotland-wide digital aerial imagery© Getmapping plc.

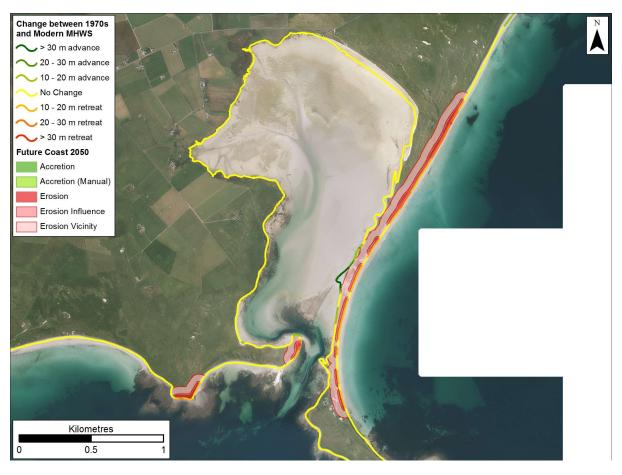
Figure 10.44: Possible future coastline position in 2050 based on rates between 1970 and Modern MHWS data at Cata Sands. Getmapping are our current providers of Scotland-wide digital aerial imagery© Getmapping plc.

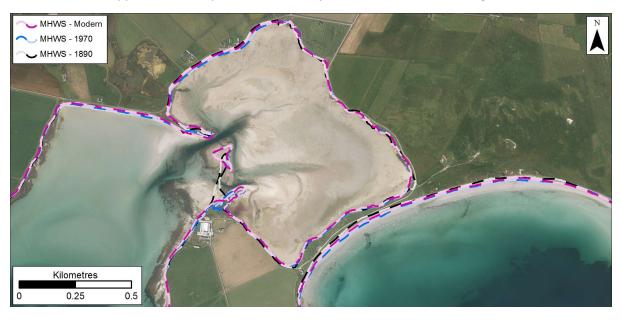
Figure 10.45: MHWS position in 1890, 1970s, and Modern datasets at Little Sea. Getmapping are our current providers of Scotland-wide digital aerial imagery© Getmapping plc.

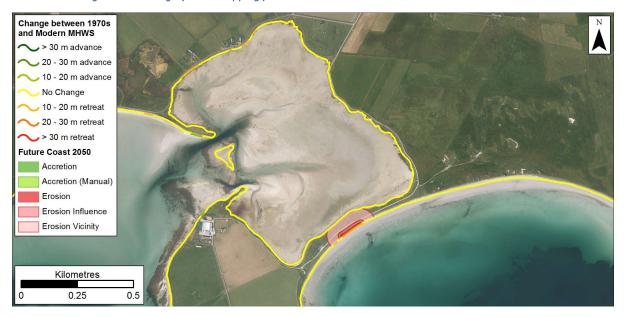
Figure 10.46: Possible future coastline position in 2050 based on rates between 1970 and Modern MHWS data at Little Sea. Getmapping are our current providers of Scotland-wide digital aerial imagery© Getmapping plc

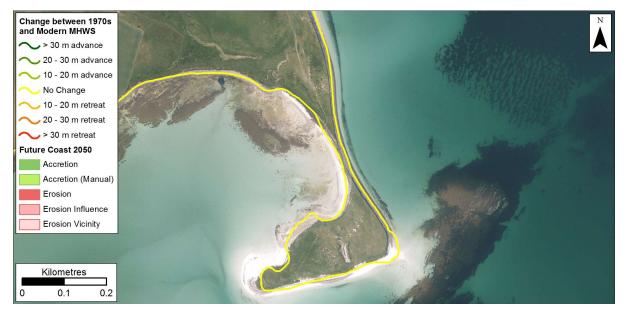
Figure 10.48: Possible future coastline position in 2050 based on rates between 1970 and Modern MHWS data at Otterswick. Getmapping are our current providers of Scotland-wide digital aerial imagery© Getmapping plc.

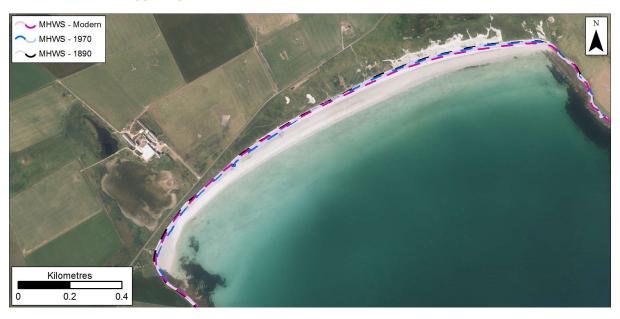
Figure 10.49: MHWS position in 1890, 1970s, and Modern datasets at the Sands of Rothiesholm. Getmapping are our current providers of Scotland-wide digital aerial imagery© Getmapping plc.

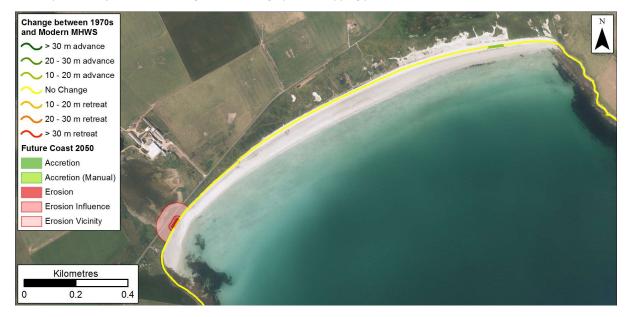
Figure 10.50: Possible future coastline position in 2050 based on rates between 1970 and Modern MHWS data at the Sands of Rothiesholm. Getmapping are our current providers of Scotland-wide digital aerial imagery © Getmapping plc.
