## Purpose of this document

This document provides a briefing on storm impacts along the shore at Golspie (Highland). This briefing note is for information and can be shared with partners and the public.

1. The town and links at Golspie have seen significant storm impacts due to large waves coinciding with high spring tides between Fri 9<sup>th</sup> and Mon 12<sup>th</sup> Feb 2024.

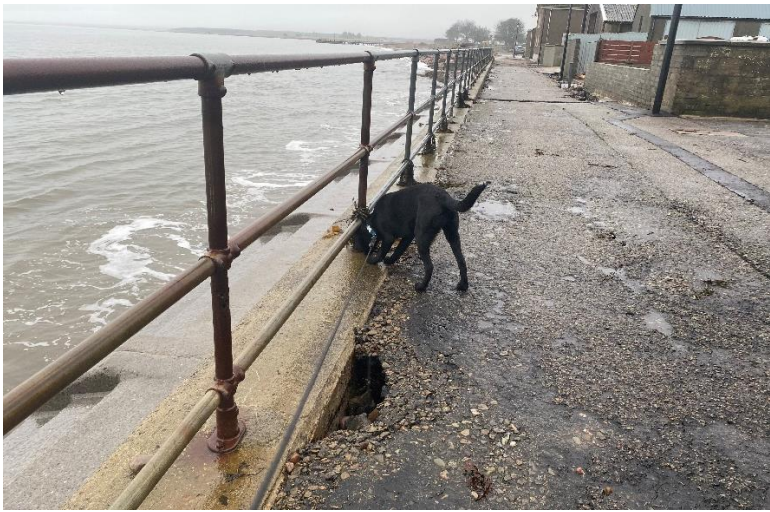
Caption, Grid Ref	Image
1. Sink hole within the prom, north of Campbell's Lane. Uncertain of when it was created. (283314, 899951)

Location	Storm impacts & observations
Golspie Prom.	Clear evidence of wave thrown debris and occasional damage to railings. By Thursday several clean-ups had taken place by Council and community. Small sink hole noted at Prom, which is indicative of undermining of sea wall – though uncertain of when this occurred. Flood gates appeared to offer reasonable protection.
Golspie beach (north of pier)	Removal of sand from upper beach, overwash of waves and storm debris within narrow corridor.
Pier to golf course	Uncertain of beach changes (tide in), but damage to railings in places and erosion of grassed areas above defences. Exposure of (presumed) 200mm water pipe.
Golf course	Erosion of land above defences, movement of rock armour, loss of path in places. Extensive areas of overwash and wave thrown debris. Club's volunteers arranged a very rapid and effective clean-up operation. Note <a href="#">Community Resilience</a> .

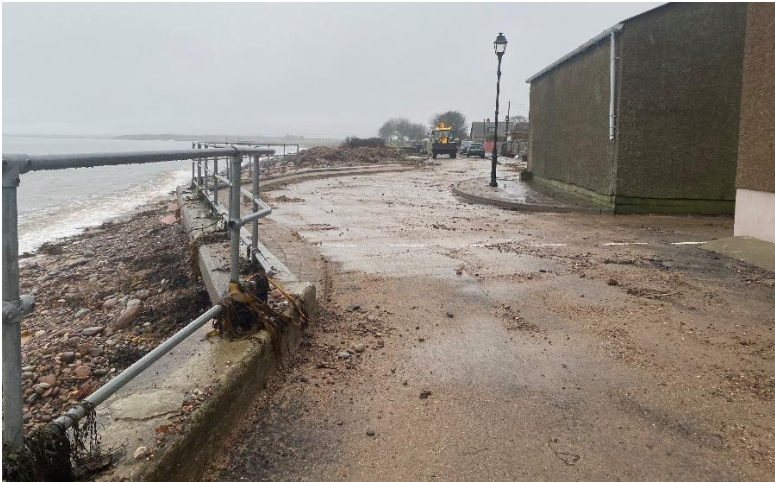
2. Some sand and kelp remain after cleanup at Campbell's Lane (to the right), looking towards Murdo's Lane. (283263, 899916)

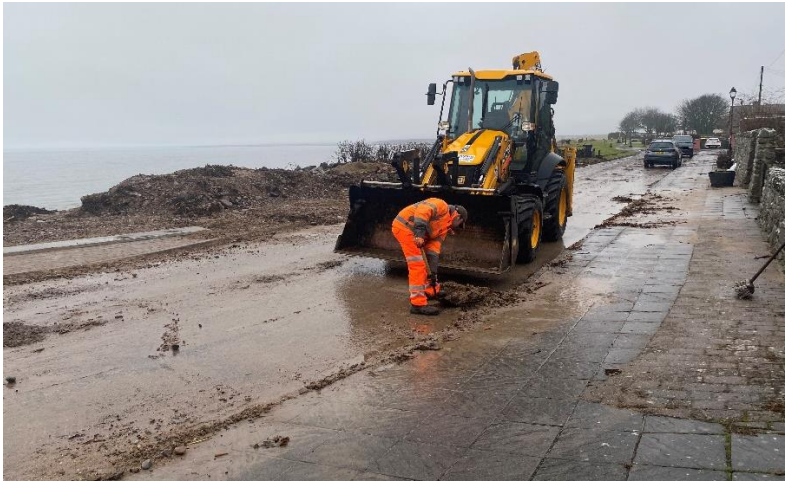
<p>3. Council staff continue to clean up at Murdo's Lane. Sediments are being returned to the shore. (283244, 899909)</p>

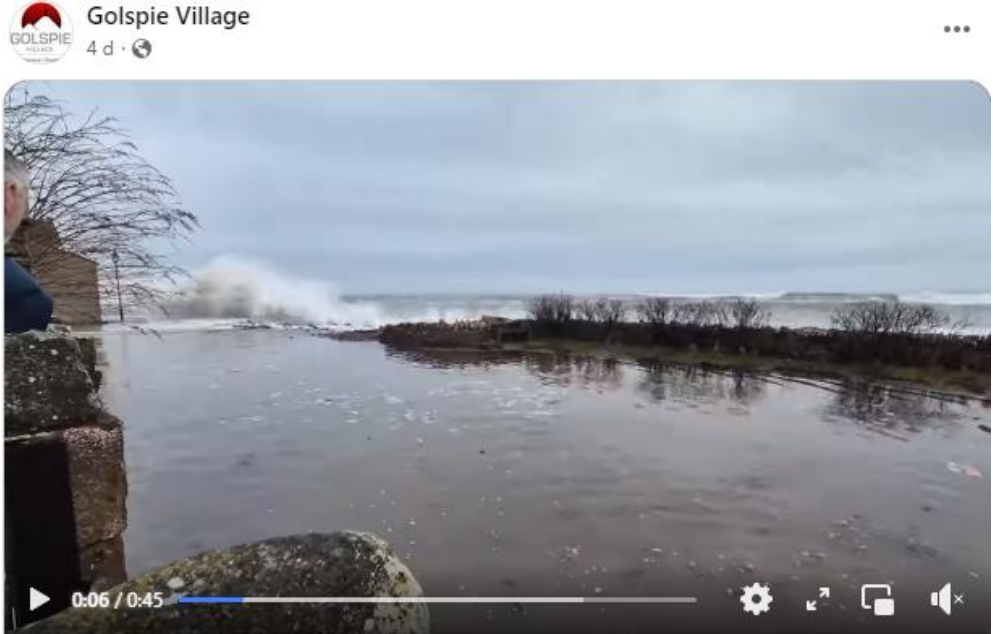
<p>4. Video of storm impacts and flooding at Murdo's Lane. (283232, 899902) <a href="#">Video Facebook</a> ©Nicki Mackay. Overtopping at 3.7mOD</p>

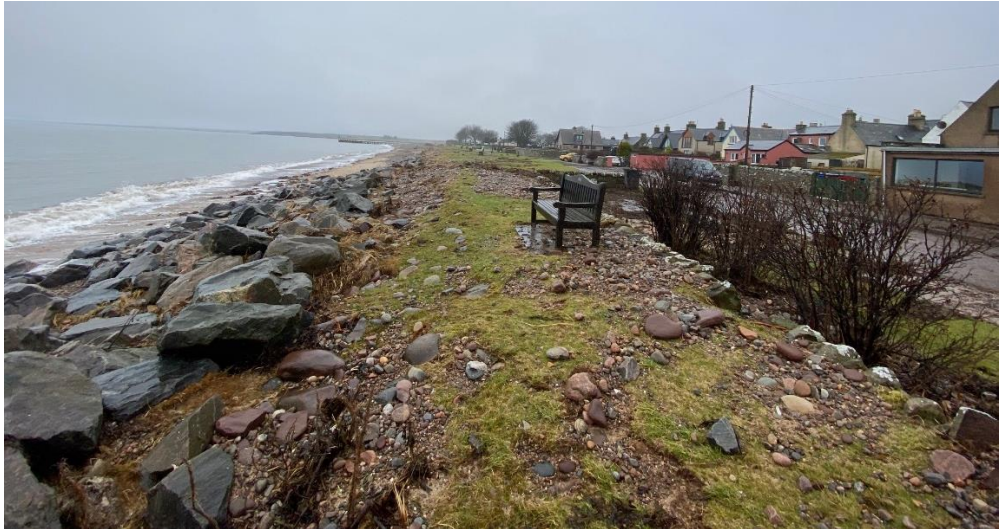
<p>5. Extensive evidence of wave thrown debris to south of Murdo's Lane. (283186, 89985). This bank (4.3mOD) was also overtopped.</p>

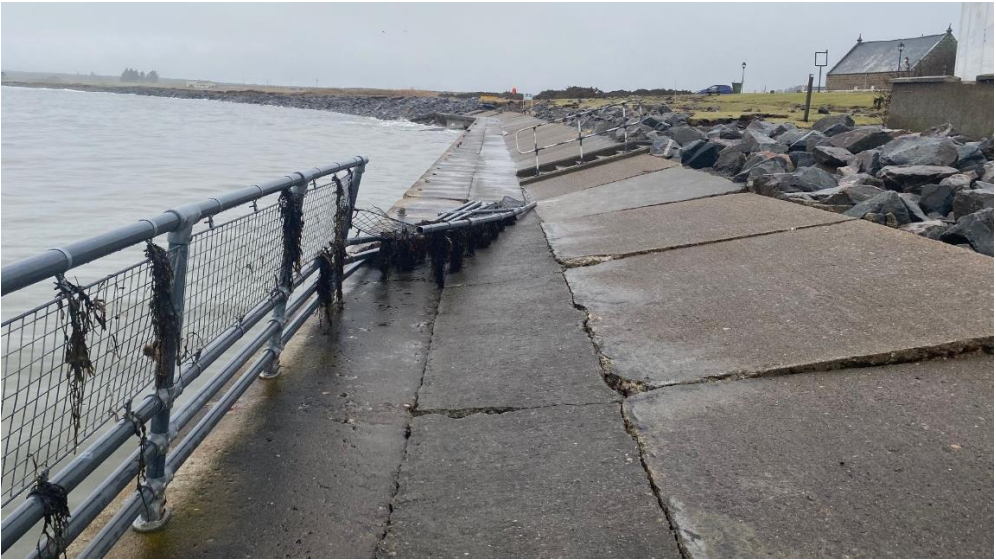
<p>6. Damage to railing south of the pier, uncertain how many of the uneven paving slabs are from this event. (282846, 899586)</p>

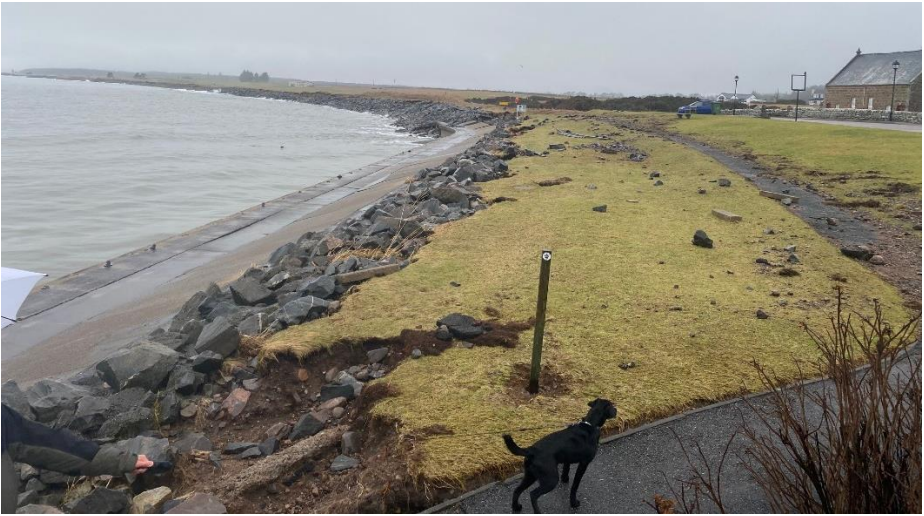
<p>7. Wave thrown debris over grassed area and erosion of grass above defences at Church St. (282804, 899564)</p>

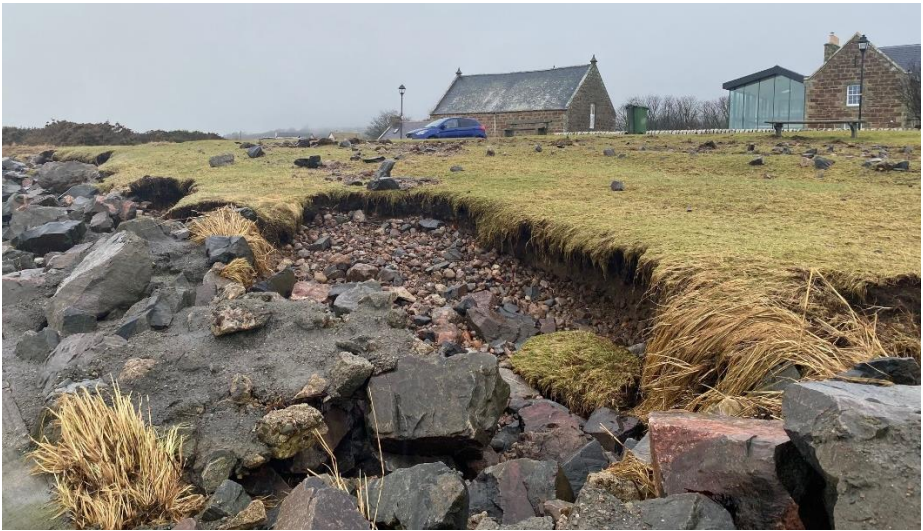
<p>8. The orientation of erosion and the position of debris (thrown to west) confirm easterly waves. Church St. (282778, 899545)</p>

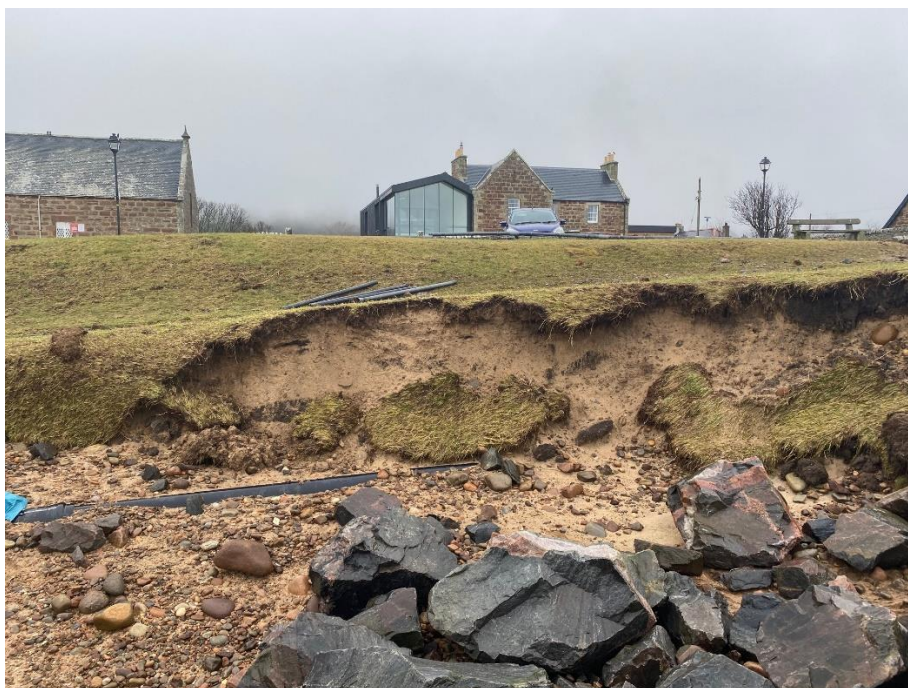
9. Exposure of 200mm pipe. Possibly a water pipe, though the main sewer is also within the vicinity here.  
(282762, 899536)

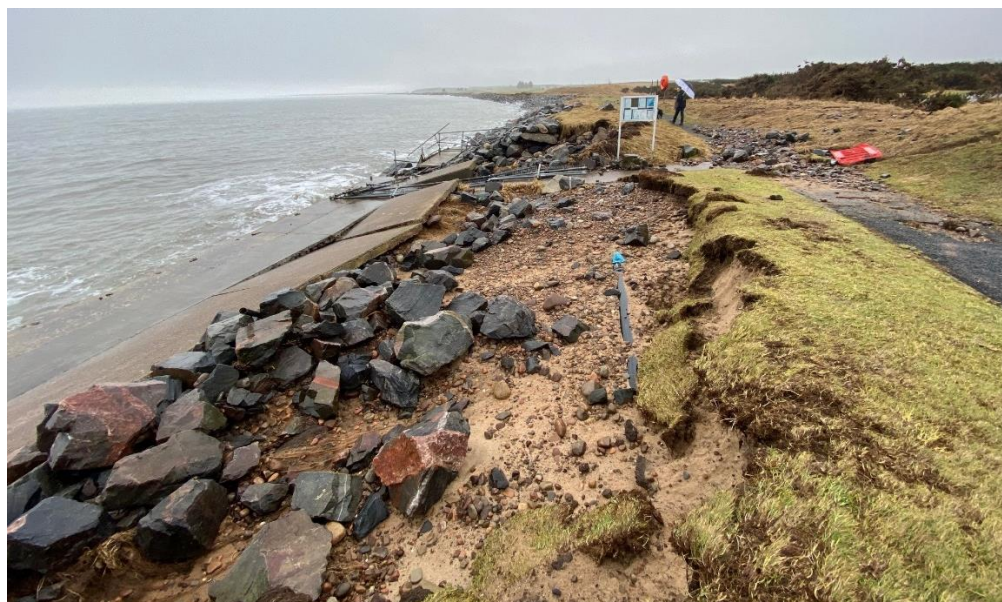
10. Erosion of land above damaged defences and damage to handrail. Debris extending inland. Note main sewer runs coast parallel here.  
(282762, 899536)

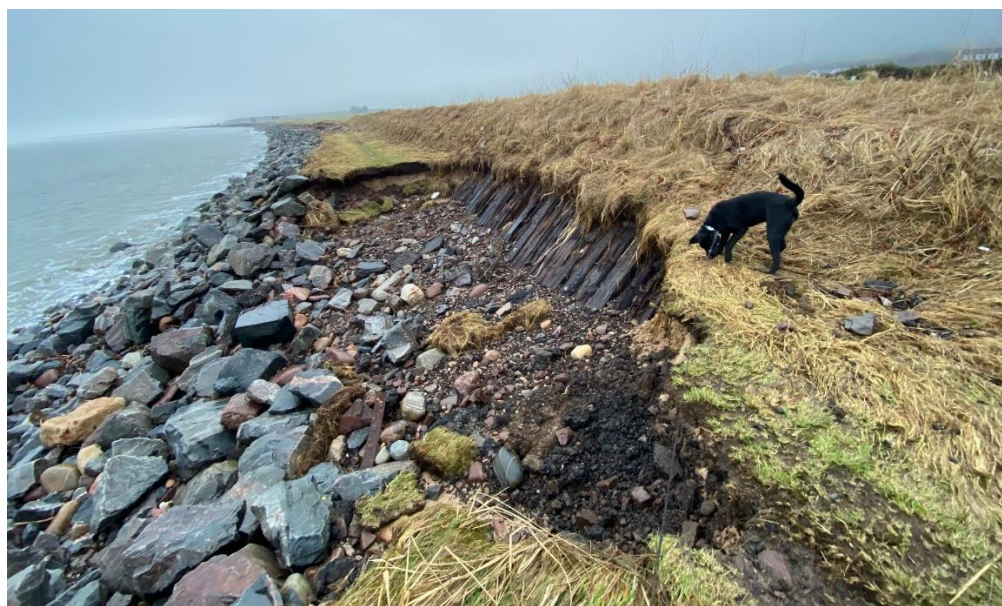
11. Re-exposure of vertical sleepers (former defences). Erosion above rock armour and loss of path, adjacent to the norther end of golf course.  
(282701,899474)

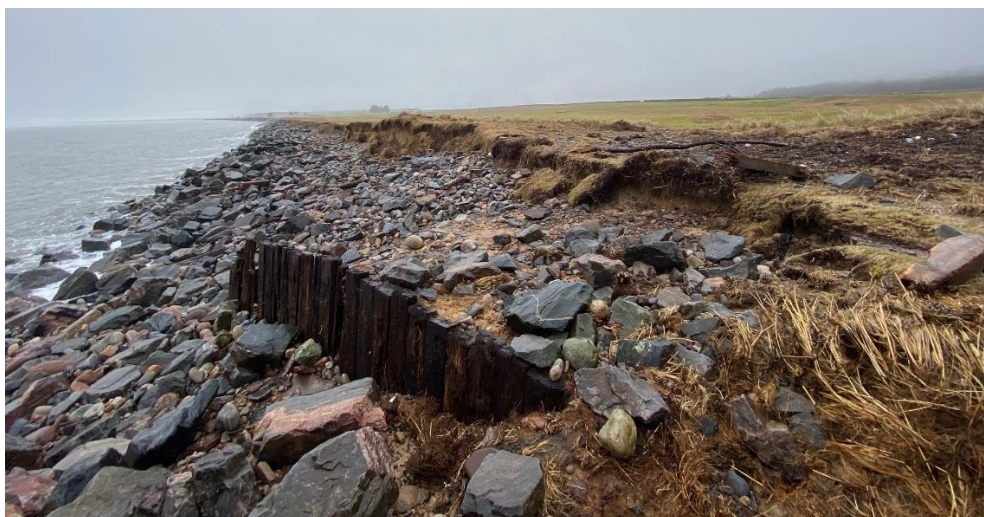
12. Re-exposure of vertical sleepers (former defences). Erosion above rock armour and loss of path, adjacent to the norther end of golf course. (282692, 899460)

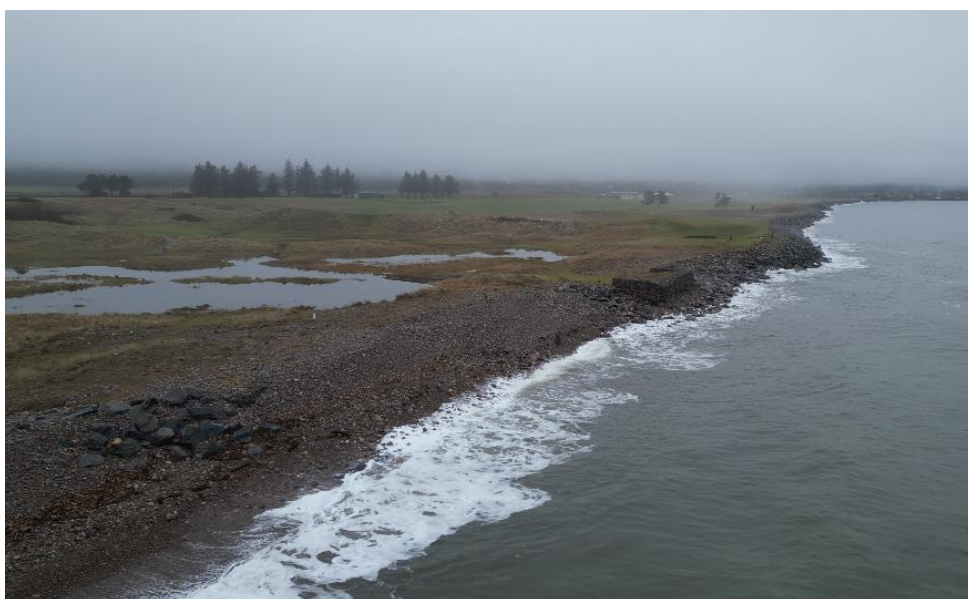
14. Waves overtopping at caravan park  
[Video Facebook](#)  
(282154, 897910)  
©Cathy Spearing

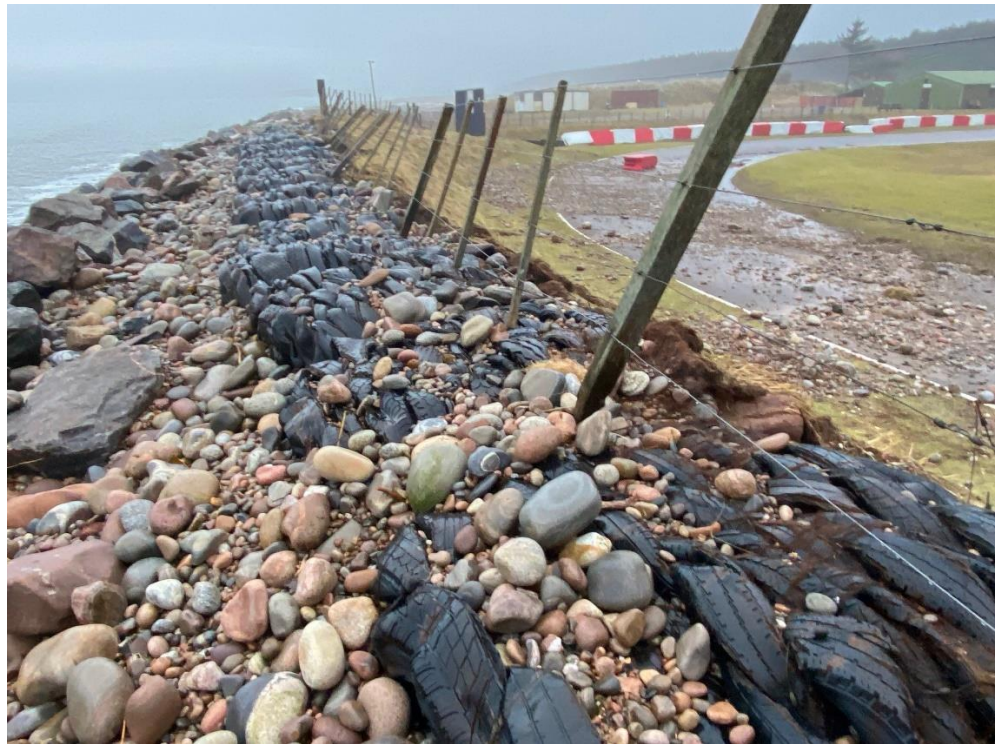
18. Unorthodox coastal defences (bales of waste car tyres) exposed at kart track. Wire holding the bales together has rusted away. Note over-washed sediment on track. (282143, 897761)

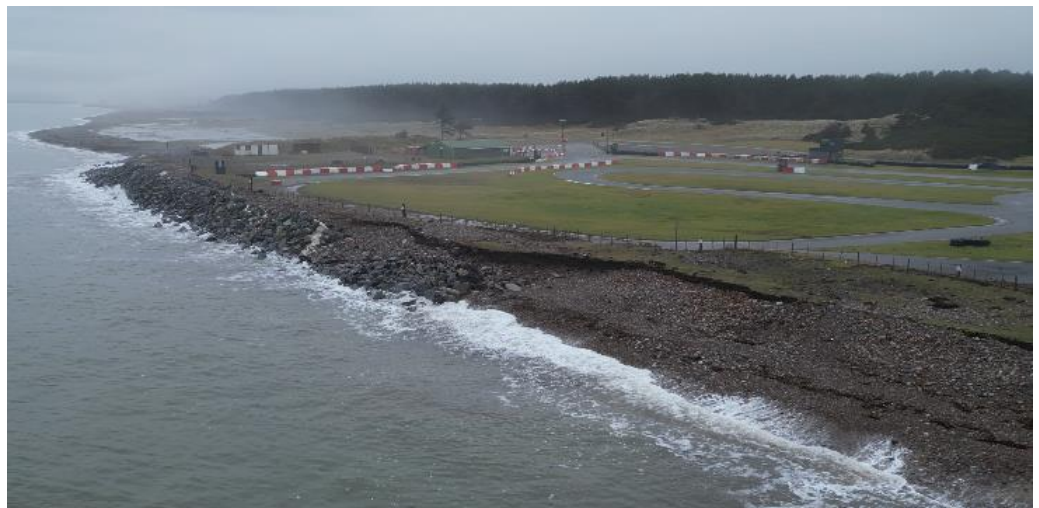
20. Southern extent of Kart Track defences washed out, exposing car tyres, which have been carried south into Loch Fleet NNR. Note erosional bight at southern end of Kart track caused by presence of defences (282111, 897668)

- f. Damage to informal defences at kart track, resulting in the release of waste tyres.
3. Clean-up efforts were rapidly undertaken within the town, golf course, caravan park and Kart Track.

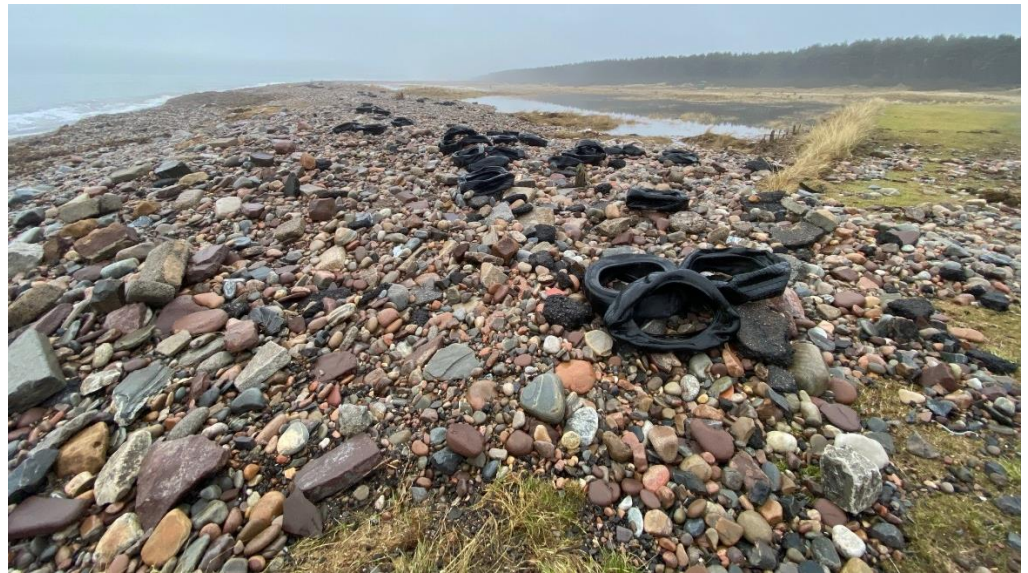
21. Wide shingle ridge retreating over into the NNR maintaining its integrity. Tyres are evident within the at least the first few hundred metres.  
(282094, 897630)
