Dynamic Coast – Scotland's National Coastal Change Assessment

Site Summary

St Andrews West Sands (Site 15)

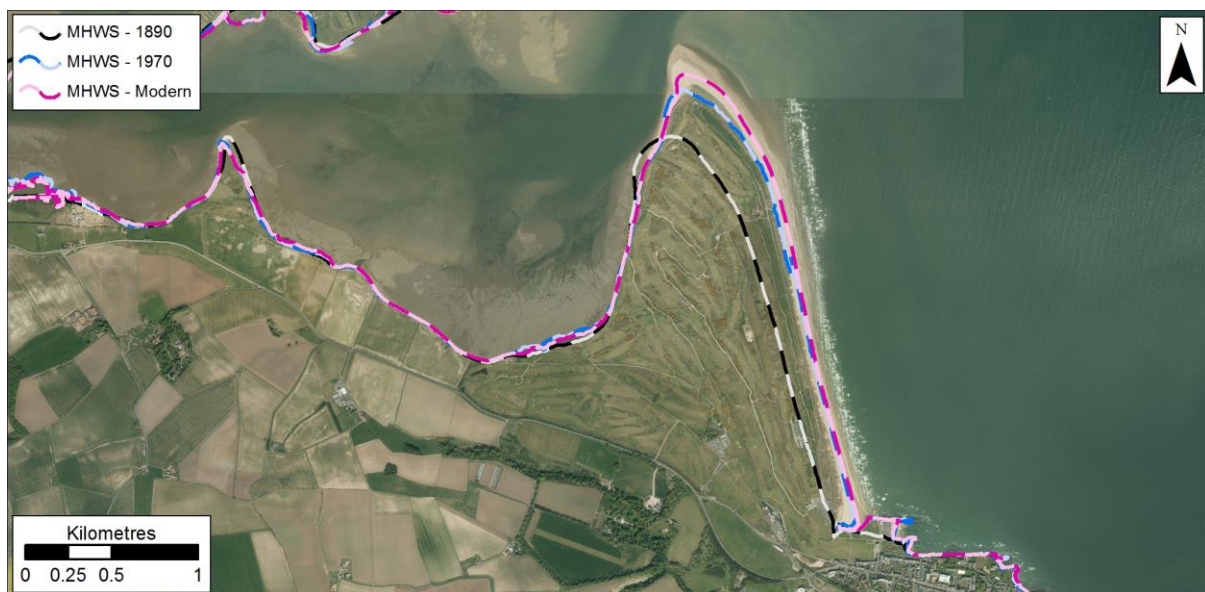
Figure 1.1: MHWS position in 1890, 1970s, and Modern datasets at St. Andrews West Sands. Getmapping are our current providers of Scotland-wide digital aerial imagery © Getmapping plc.

Historic Change: St Andrews West Sands lie to the north of the town and encloses the Eden Estuary to the west. In 1896, the links were around 180 hectares, however by the early 1990s an additional 50 hectares had been gained and by 2009 a further seven hectares, all through natural processes (Figure 1.1). The additional area since 1896 has provided sufficient land for almost half of the Jubilee Course, the access road and several car parks. At the southern end of West Sands, the beach accreted some 150m in the intervening century, and towards the northern limit, Out Head had advanced seawards by over 250 m (2 m/yr). The eastward movement of Out Head has occurred in conjunction with erosion of its western edge, where some 60 m of retreat occurred over the same period. Along the Eden estuary coast some apparent accretion of the salt marshes as the shoreline turns towards the west is observed with MHWS advancing seawards some 50 m (0.5 m/yr).

Since the early 1990s a similar pattern of accretion has continued, although at half the rate. The southern end of the West Sands has advanced almost 20 m between 1993 and 2009 but again towards Out Head, the dunes had advanced eastward by up to 100m (approaching 3 m/yr) (Figure 1.1). The area of erosion just south of Out Head on the Eden coast continues within the recent change analysis. This is likely related to the increased effect of short westerly waves at high tide, this part of Out Head being increasingly the most exposed to such effects, although movement of the main channel of the River Eden cannot be ruled out. The last few decades have also seen some beach and dune erosion along the Eden Estuary coast of the Jubilee Course (managed by sloped gabion baskets and a now repeated beach feeding programme) and several blow outs have occurred along the dune cordon of West Sands. Despite the seaward movement of MHWS at the Swilcan Burn (at the southern end of West Sands), some dune reinstatement and dune grass planting has been carried out nonetheless. These works may reflect the considerable visitor pressure in this area alongside natural fluctuation and processes.

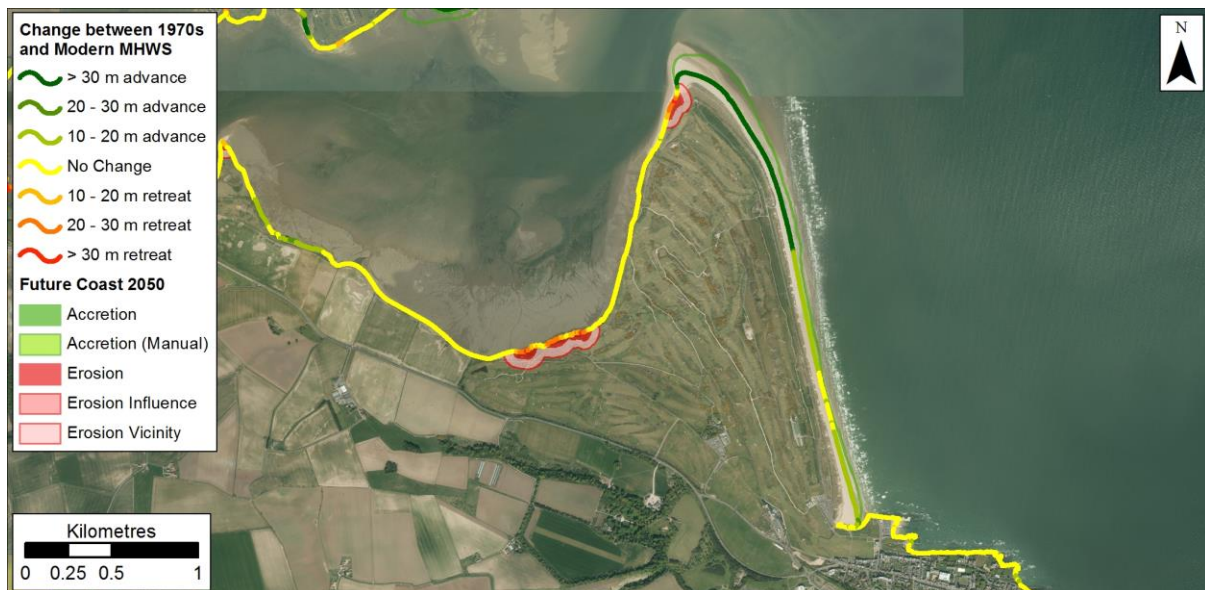
Figure 1.3: Possible future coastline position in 2050 based on rates between 1970 and Modern MHWS data at St. Andrews West Sands. Getmapping are our current providers of Scotland-wide digital aerial imagery© Getmapping plc.

Vulnerability Assessment: The vulnerability assessment projects the past rates into the future to give a sense of the potential impact in areas of increased risk by 2050. Within the dunes at St Andrews there are two areas where there has been significant erosion and/or landward migration of MHWS, firstly to the northern Eden Estuary coast and secondly to the south within the area of the salt marsh (Figure 1.3). If the past rates continue then the MHWS of 2050 is anticipated to move up to 40 m inland and will overlap onto areas of the golf course in the south. In the north, any anticipated erosional footprint is some 20 m away from any golf course assets. Both the West Sands and Eden Estuary are designated for their natural heritage interests and the erosion does occur within known areas of flood risk (200yr extent).
