Dynamic Coast – Scotland's National Coastal Change Assessment

Site Summary

Morrich More / RAF Tain (Site 38)

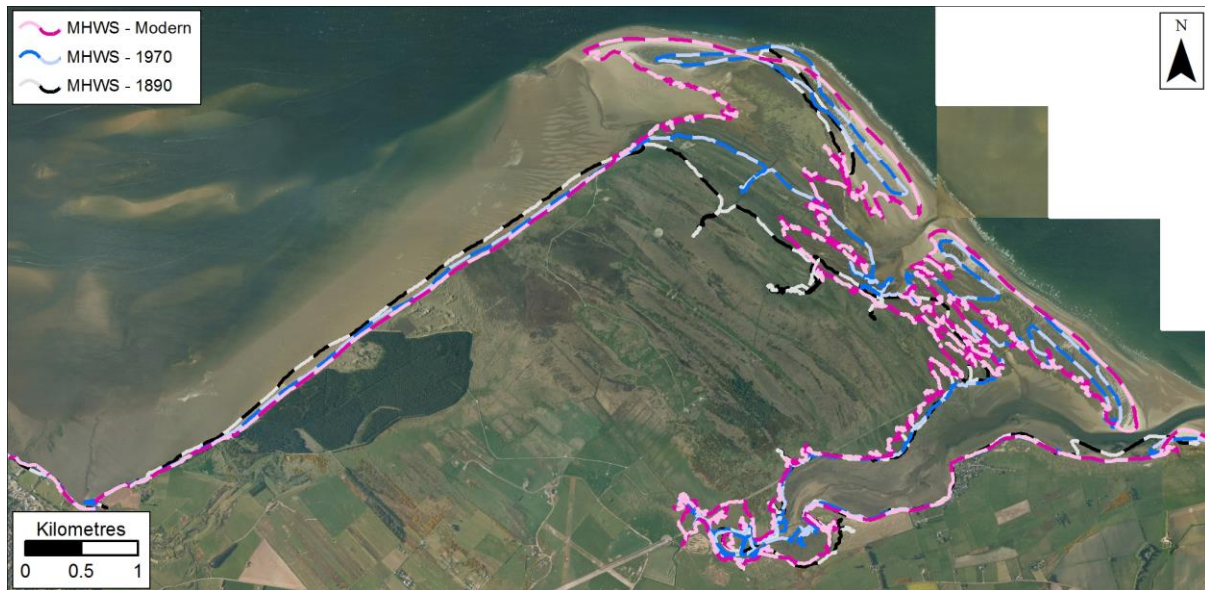
Figure 3.1: MHWS position in 1890, 1970s, and Modern datasets at Morrich More. Getmapping are our current providers of Scotland-wide digital aerial imagery© Getmapping plc.

The western flank of Morrich More extends 7 km from Tain to the Island of Innes Mhor. Between 1904 and 1977 almost all of it has experienced substantial erosion, resulting in the loss of approximately 14 ha of mainly high dunes (Figure 3.1). In places this reached over 100 m (1.3 m/yr) but most sections lost closer to 60 to 70 m. These losses are substantiated by the presence of former terrestrial peat deposits becoming exposed on the foreshore. Changes on the easterly facing shore are equally dramatic where substantial accretion has occurred. Behind Innes Mhor, in the 73 years after 1904, MHWS has advanced seawards some 460 m and 78 ha of new habitat above MHWS has been formed. Paterson Island (the southerly barrier island) has also formed in this period, resulting in 54 ha of new land. Taken together the 132 ha equates to 1.8 ha/yr (or one and a half football pitches every year).

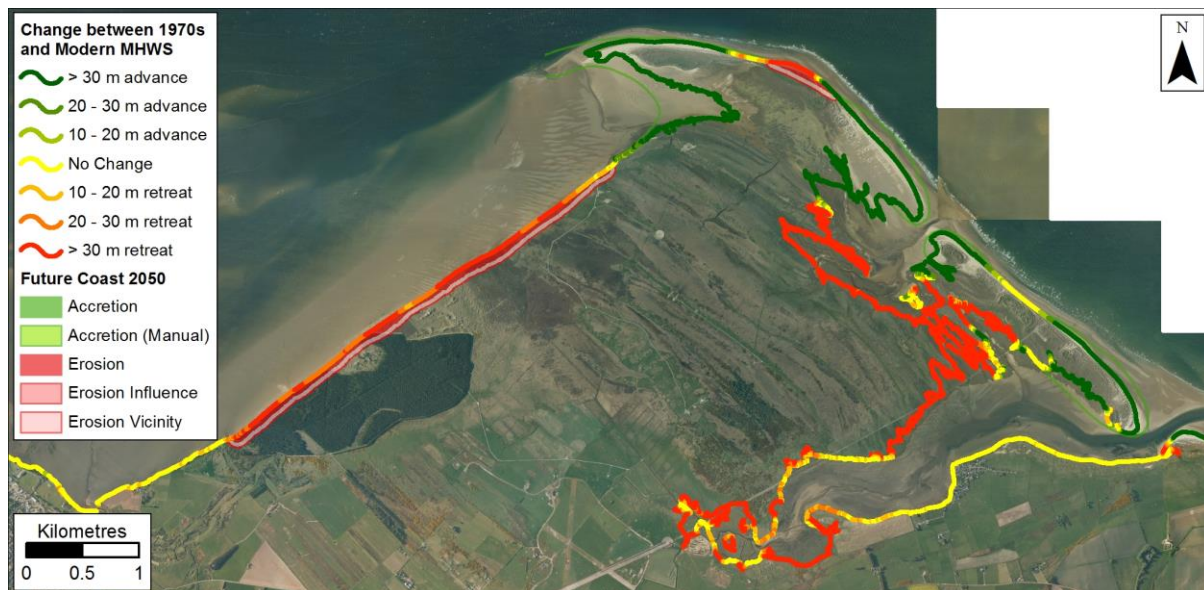
Figure 3.2: Possible future coastline position in 2050 based on rates between 1970 and Modern MHWS data at Morrich More. Getmapping are our current providers of Scotland-wide digital aerial imagery© Getmapping plc.

Future Vulnerability: The vulnerability assessment projects the past rate of change into the future for a 2050 and 2100-year shoreline, which is then compared with assets. The initial section of shore from Tain is protected with rock armour then a series of near-shore breakwaters. The methodology excludes these defended areas from the projections for the future coast. However, to the northern limit of the breakwater a 25 m deep erosional bight already exists and by 2050 this is expected to retreat a further 50 m, exacerbating the losses to the forestry plantation (Figure 3.2). The remainder of the western-facing flank of Morrich More is expected to continue to erode as it has for the last 7,000 years. This will result in the loss of some forestry plantation, something Forestry Commission Scotland anticipates within their harvesting schedule. Alongside the trees, nature conservation designated sites will be eroded. The analysis here suggests in area terms at least, the gains are more than compensating for the losses, however the scientific quality and ecosystem services are defined by more than a measure of extent.
