Dynamic Coast - Scotland's National Coastal Change Assessment

Site Summary

Dornoch Point & Sands (Site 39)

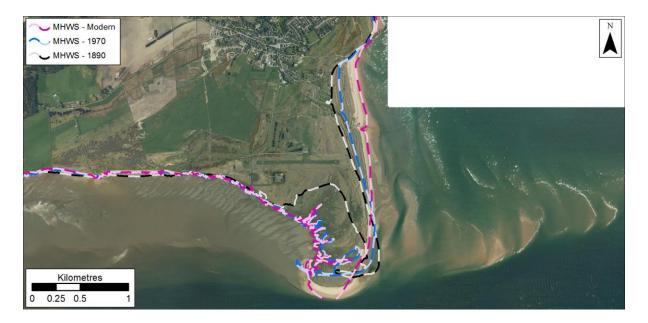
Figure 3.1: MHWS position in 1890, 1970s, and Modern datasets at Dornoch Point. Getmapping are our current providers of Scotland-wide digital aerial imagery© Getmapping plc.

Much of North beach has remained stable between 1905 and 1980. However, a 280m section of beach did retreat between 20 or 30 m (up to 0.3 m/yr) during this period (Figure 3.1). Middle beach was also stable with insignificant changes up to 1977. The bulk of the changes have occurred on South beach where the shoreline has advanced seawards up to 100m between 1905 and 1980 (1.4 m/yr). Parallel dune ridges and hollows lie where the beach was in 1905. The southern tip of Dornoch Point has been clipped back almost 100m in 75 years, and has moved westwards with a 1905 spit extending some 400m to the west. These active dunes enclose 38ha of salt marsh that has accumulated in the intervening 75 years, with remarkable seaward advances of MHWS (above 400m). Within Dornoch Sands, much of the coast is stable with only a small section of minor erosion fronting the Struie golf course.

Once again, the modern OS MHWS has seen little update, with only minor revisions at the northern end of South beach. The analysis here therefore relies on the 2011 Scottish Government LiDAR survey. North beach has seen accretion within the vicinity of the earlier losses, largely negating them. Middle beach has advanced up to 30m between 1977 and 2011 (0.9 m/yr), and the accretion at South beach has accelerated. Here since 1979, MHWS has advanced seawards up to 220 m (6.8 m/yr). The advances, like the earlier period, are curtailed towards the Point where erosion dominates on the easterly facing edge. Since 1979 Dornoch Point continued to move south up to 250 m, occupying its most southerly position yet. Further accretion occurred within the enclosed spit, however much of the 1.5 km of shore remained largely stable since 1979. The notable exception to this is a small area of erosion abutting the Struie golf course that is now the subject of a proposed rehabilitation project. Recent erosion has also occurred on adjacent farm land, however the remainder of the bay to the west is largely stable.

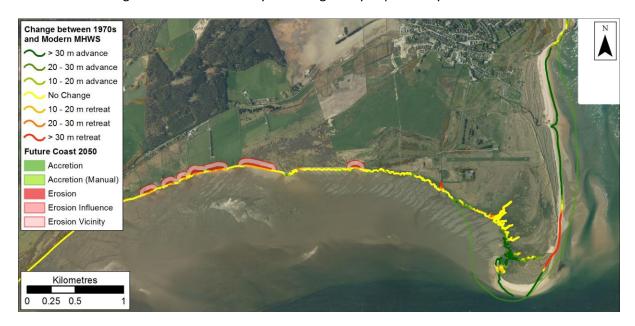
Figure 3.2: Possible future coastline position in 2050 based on rates between 1970 and Modern MHWS data at Dornoch Point. Getmapping are our current providers of Scotland-wide digital aerial imagery © Getmapping plc.

Future Vulnerability: The future shorelines on North, Middle and South beach at Dornoch are expected to be stable or accretional in the future. Dornoch Point is expected to continue to broaden and move westwards, as it has done over the last 111 years (Figure 3.2). Further west however, the historical retreat rates have been projected landwards and erosion is anticipated within the Struie golf course and farmland 1km to the west. Apart from the farmland there are few built assets in this area, although there are two houses which are about 60m from the 2100 MHWS line. The nature conservation designated sites are unlikely to be negatively impacted by the erosion.
