Stevenston & Irvine: Site Investigation

North Ayrshire Council

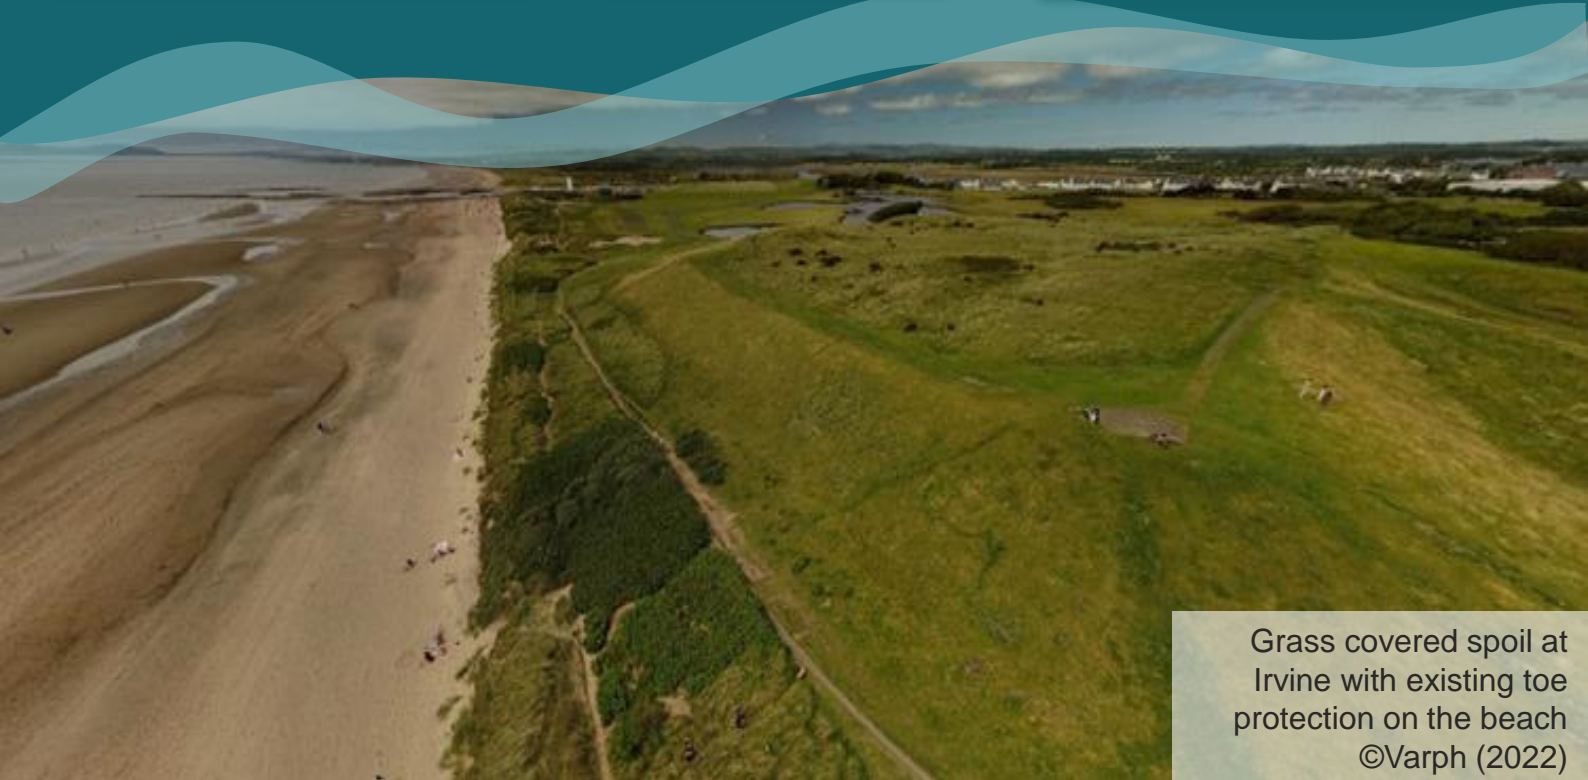
Grass covered spoil at Irvine with existing toe protection on the beach
©Varph (2022)

Our project aims to verify the composition and location of suspected contamination on and around the existing shoreline at Irvine and Stevenston. The outcome of these site investigations will inform future adaptation planning and actions. At Irvine, the existing toe protection that was recently revealed by reduced beach levels indicates that previous decision-makers recognised the need to protect the spoil from erosion processes. At Stevenston, historic colliery spoil is actively eroding.

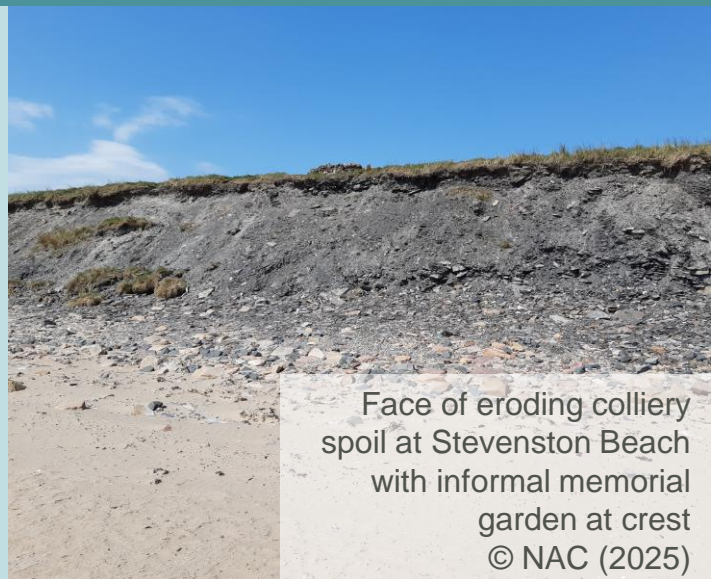
Face of eroding colliery spoil at Stevenston Beach with informal memorial garden at crest
© NAC (2025)
